J. WYNDHAM PRINCE

CONSULTING CIVIL INFRASTRUCTURE ENGINEERS
& PROJECT MANAGERS

BURNUM BURNUM WETLAND INVESTIGATION OF UPSTREAM DRAINAGE SYSTEM

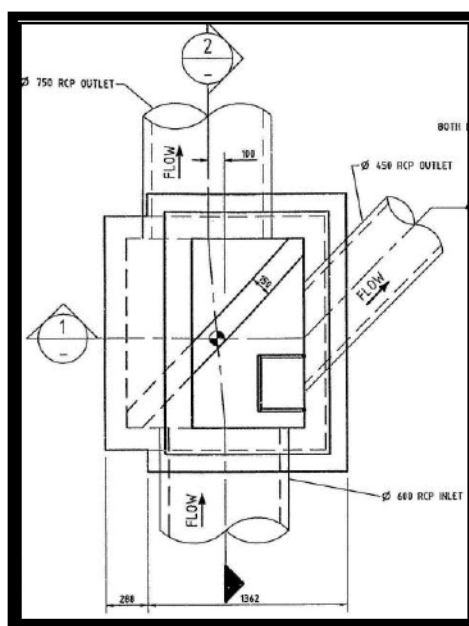
Figure 3 Diversion Pit AG5 (lid removed)

The SSC maintenance crew removed the lid to the Diversion Pit and described a previous clean of the pit, which they had carried out concurrently with the commissioning of the Woronora Bridge. A significant amount of sediment was observed upstream of the diversion weir and extending into the low flow outlet, resulting in a shallow pool of standing water upstream of the weir. Pit lids and surrounds appeared to be intact. Free standing water was evident downstream of the weir, indicating a possible blockage in the line leading to the wetland (refer to Photo 4).

- ☐ CCTV scans of the low flow pipeline between AG5 and AB1 (undertaken on 23/1/12).
- ☐ Any sediment present in the pit and pipeline to be removed by SSC contractor using a high pressure jet of water and vacuum eduction during the CCTV inspection.
- ☐ Streamlining (channelised benching) within the invert and sides of the pit, upstream and downstream of the weir, to reduce the hydraulic losses through the pit, improve flow characteristic and prevent sediment build-up. Streamlining and benching should also occur within the Kerb Inlet Pit AB1 and the Junction Pit AB2.

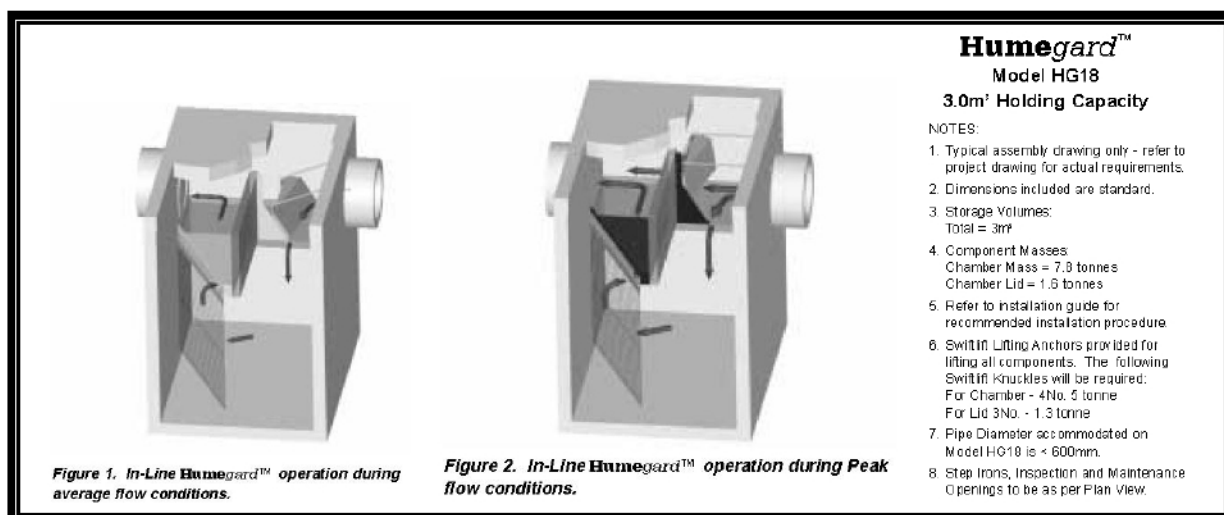
Figure 4 Humegard™ Model HG18 - Internal Workings

Shown as an In-Line-Litter Separator on the RTA plans. However, these devices are now manufactured by Humes Pty Ltd, and this particular device appears to be a Humegard™ Model HG18. Dimensions are provided in the table below and on Figures 4 and 5.

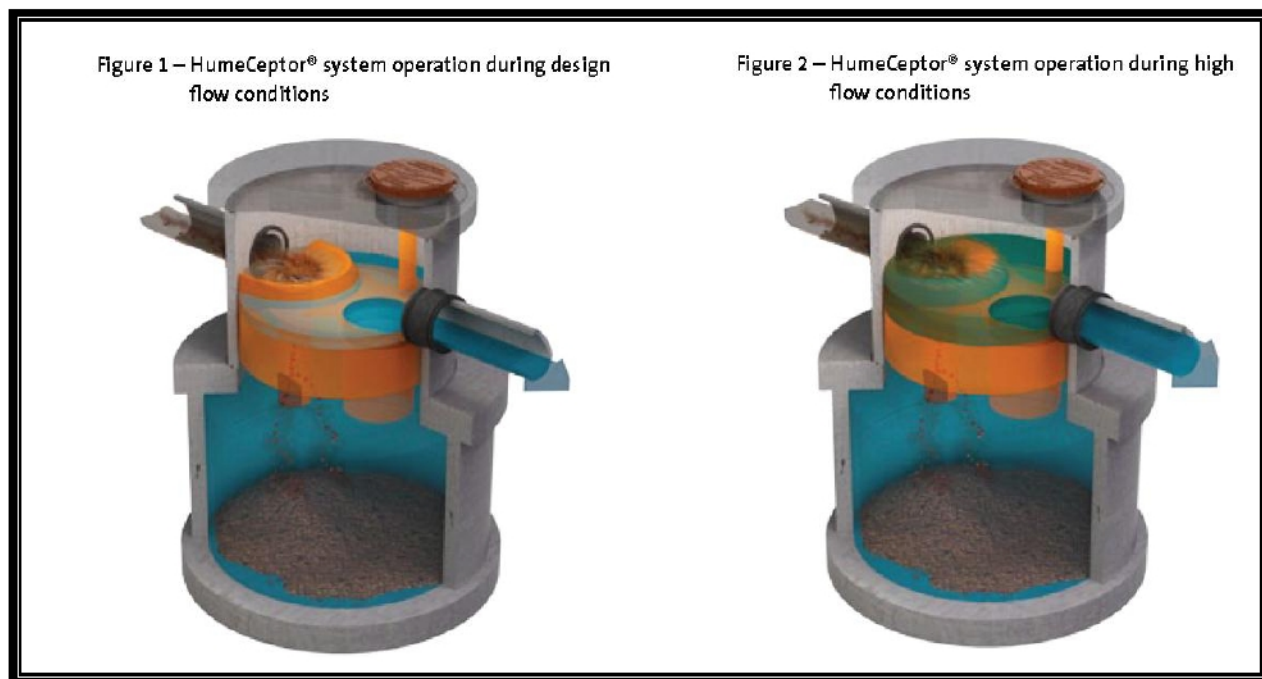
Figure 6 Humeceptor™ Operational Details

The Treatable Flow Rate (TFR) for an STC14 HumeCeptor™ is 30 L/s. However, the peak inflow to the Humeceptor™ is 550 L/s (1-year ARI per Sheet 2 RTA Plan 0663.411.ED.0003). The 3-month ARI (generally the target treatable flow rate for stormwater treatment measures) is estimated to be 290 L/s (extrapolated from the 1-yr ARI). Consequently the Humeceptor™, even if its inlet were not blocked, is unable to control the anticipated volume of oil and grit that would be generated by the upstream catchment during a rainfall event, within the catchment, that generated a depth of flow in excess of 200 mm within a 450 dia pipe (height of the diversion weir within the Humeceptor™).

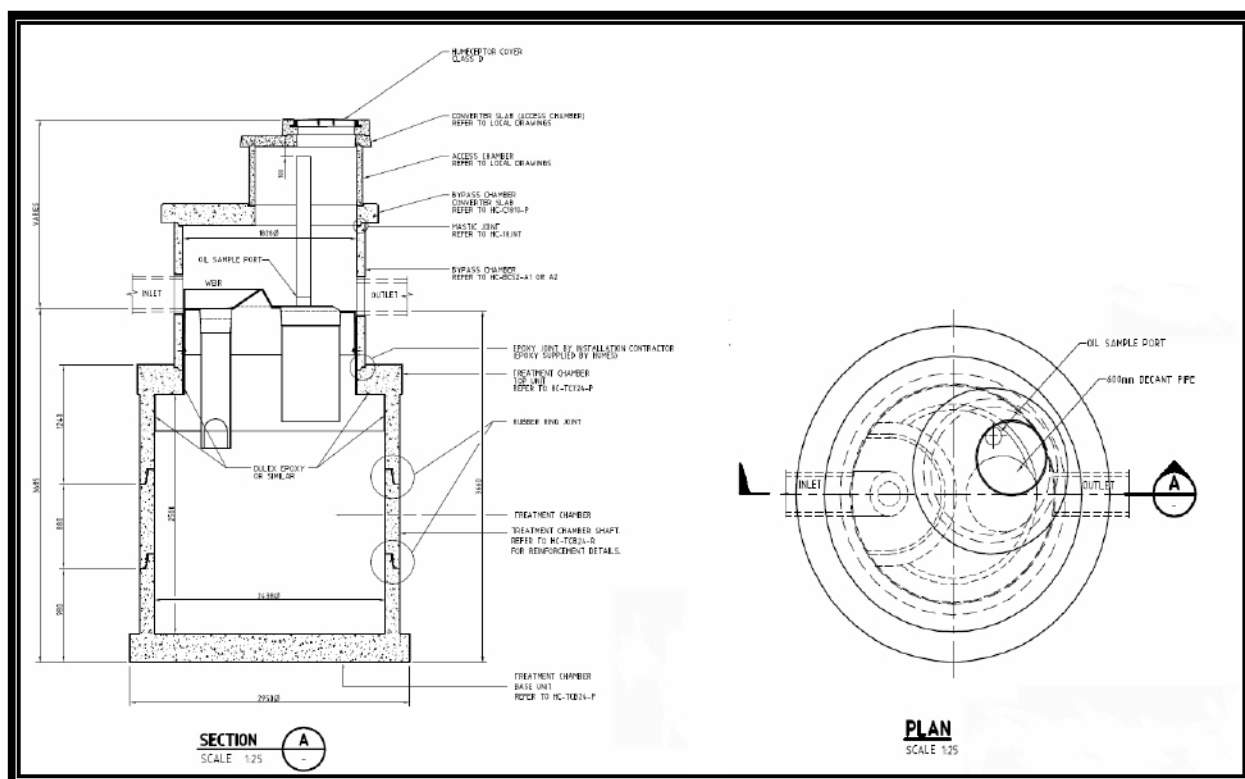
Figure 7 Humeceptor™ STC14 - Plan and Section

According to the RTA design plans, this Humeceptor™ is an STC14 model, which is manufactured by Humes Pty Ltd. Refer to the table below for unit dimensions and details.

Similarly, the depth of sediment can be measured from the surface without entry into the Humeceptor™ through the use of a clear sediment sampling tube, which is inserted into the oil sampler port or the 610 mm opening in the floor of the inlet chamber (refer to Figure 7).

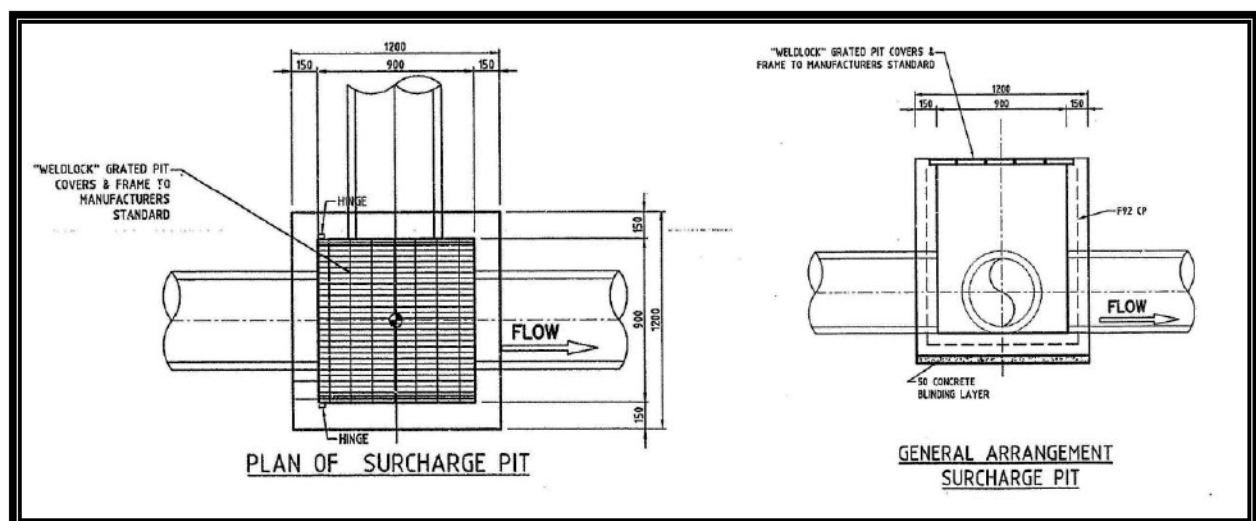
Figure 8 Details of Surcharge Pit AB4 and Junction Pit AB2

Large volumes of litter and coarse sediment were observed surrounding this pit during the site inspections (refer to Photo 11). The site inspections were post recent storm events and it appears that the grate on the pit is lifting (not desirable) and surcharging large amounts of gross pollutants and coarse sediment. The drainage system has been designed to convey and treat a peak flow equivalent to the 1 in 1-year storm event, or 550 L/s. Consequently it must be assumed that this pit is surcharging at flows less than 550 L/s or more frequently than once every year.

Flows surcharged from Pit AB4, and overland flows from upslope of it, are currently diverted to an existing reinforced concrete box culvert (RCBC), located beneath the access road, and discharges directly into the Woronora River. The Draft Burnum Burnum Wetland Management Plan proposes to raise the entry to the RCBC, which would possibly divert more flow back towards the wetland.

- ☐ Undertake a detailed hydraulic investigation of the pit and drainage system to determine level of surcharge in comparison to access road levels and backwater effects from wetland.

- ☐ Undertake detailed design of modifications to Surcharge Pit AB4 increase flow to wetland.
- ☐ Discussions on site indicated that raising the top of the existing Surcharge Pit but keeping the grate slightly lower than the pavement level on the access road may allow more of the low flows to discharge to the wetland before surcharge at the pit occurs. The level for the top of the pit is critical and must allow sufficient head to develop within the Surcharge Pit thereby diverting the majority of the inflow towards the wetland, with the residual diverted to the box culvert without flooding of the access road. This may also require some localised site regrading to allow surcharge flows to enter the wetland via a depressed overland flow path and/or stabilization of the inlet to the existing box culvert.

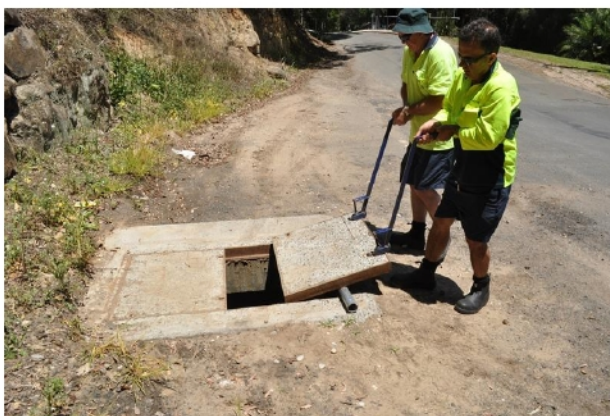
Photo 3 - Removing the Lid from Pit AG5

To facilitate visual inspections of this pit, a change to the design of the lid to incorporate a grate rather than a sealed lid was suggested. However, the maintenance staff from Sutherland shire Council (SSC) can, without much effort, remove the existing lids using two (2) Gatic Long Handle Manhole Pit Lifters (refer to Photo 3).

The lids to the pit are intended to be removed with the aid of two (2) Gatic Long Handle Manhole Pit Lifters. Once the lids are removed, access to the invert of the pit from the surface, is possible.

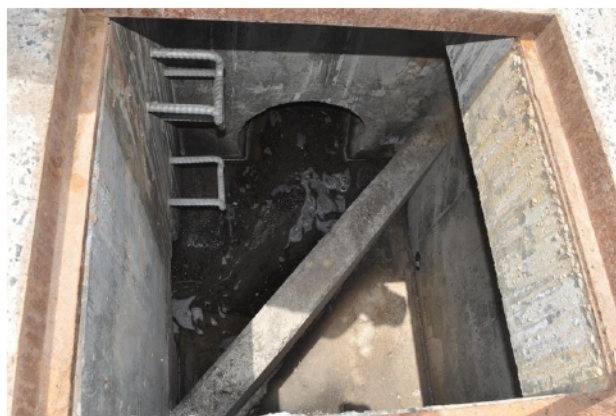
Photo 4 - Debris & Sediment within Pit AG5

The weir creates a drop in the energy of the inflows which can result in the larger debris being deposited upstream of the weir. This debris and sediment must be removed by vacuum eduction.

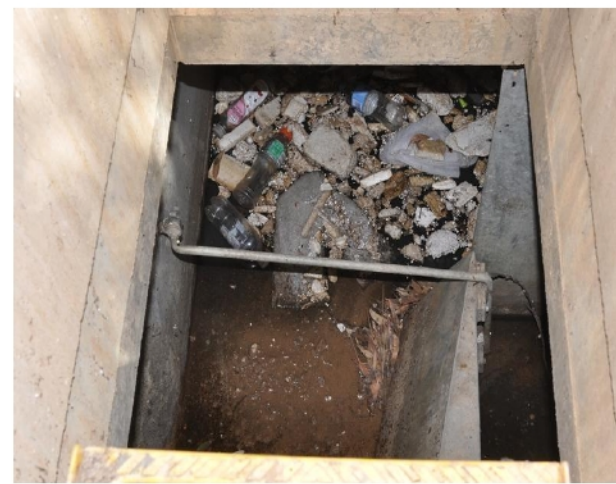
Photo 6 - Litter & Boom inside Humegard™

The boom operates best when there is a slight backwater effect and the inflow velocities are less than about 1.5 m/s (estimated existing velocity 3.5 m/s upstream and 5.5 m/s downstream). The grade on the outlet pipe is in excess of 7%, which is not conducive to the formation of a backwater effect at the boom (refer to Photo 6).

- ☐ Repair the pit lid and frame.
- ☐ Clean out the sediment accumulated around the boom and within the storage/treatment chamber.
- ☐ Remove the pipe from the Woronora bridge deck from the storage/treatment chamber and re-connect it to the upstream Junction Pit AB2.

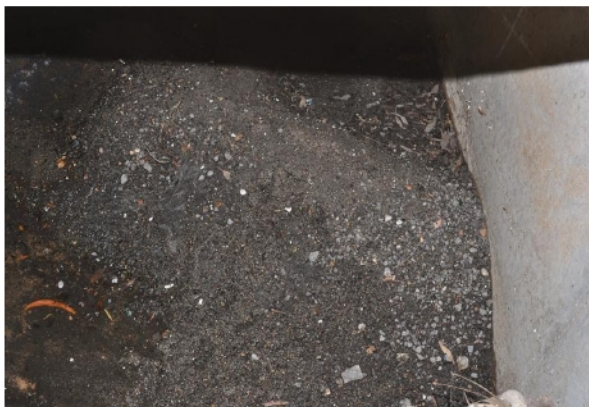
Photo 7 - Sediment Downstream of Boom

A large sediment plume was observed immediately downstream of the boom and this needs to be removed as it may hamper the efficient operation of the boom (refer to Photo 7).

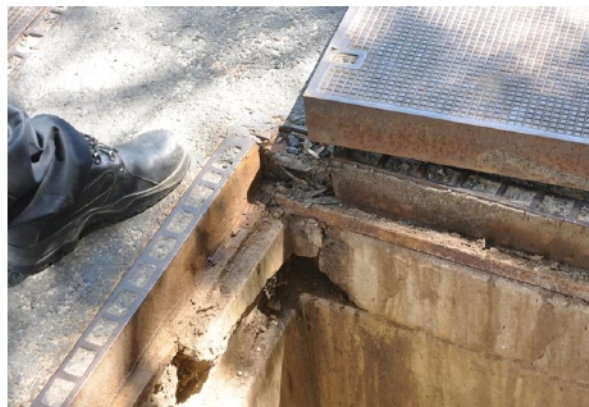
Photo 8 - Structural Defects around Frame

Upon lifting the lid to access the device, which consists of a floating boom, storage/treatment chamber and screen, the concrete supporting the steel lid surround was observed to be failing with sections of the road pavement falling into the storage/treatment chamber.

Some of the original construction formwork was also observed to be still in place and this material should be removed. Further, the concrete supports for the steel lid surround need to be repaired and these repairs could be carried out at the same time as the other works are undertaken (refer to Photo 8).

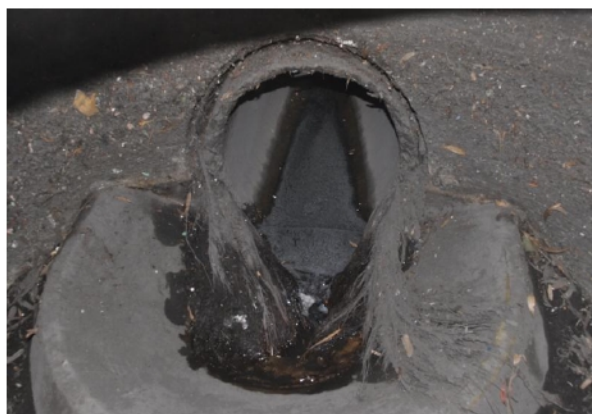
Photo 10 - Inlet Blocked by Tree Roots

Inspection of the Pit AB2 identified that the joint between the inlet pipe and the OGS had been compromised, allowing the ingress of tree roots which had subsequently blocked the orifice to the inlet drop pipe (refer to Photo 10). This blockage appears to have resulted in the inflows surcharging the diversion weir and by-passing the treatment chamber altogether.

Potential obstructions at the inlet can be observed from the surface (refer to Photo 10). To facilitate access to such obstructions, the fiberglass insert has been designed for use as maintenance platform, to allow for the removal of any obstructions by hand, or flushing of the pipeline, or carrying out a CCTV camera survey. Where entry to the device is required compliance with Confined Spaces Entry requirements must be observed

- ☐ Repair the lid surround.
- ☐ Remove the tree roots.
- ☐ Repair the joint between the inflow pipe and the Humeceptor™.
- ☐ Initiate a routine (weekly) inspection regime of the Humeceptor™ (refer to Heading 8.3) and undertake dewatering and de-silting of the Treatment Chamber immediately following any rain event that generates runoff i.e. after a rain event of approximately 15 mm in 24-hours.

- ☐ Remove the root mat blocking the inlet to the vertical dropper into the Treatment Chamber of the Humeceptor™ and repair the joints in the pipe system which have allowed their entry into the Pit AB3;

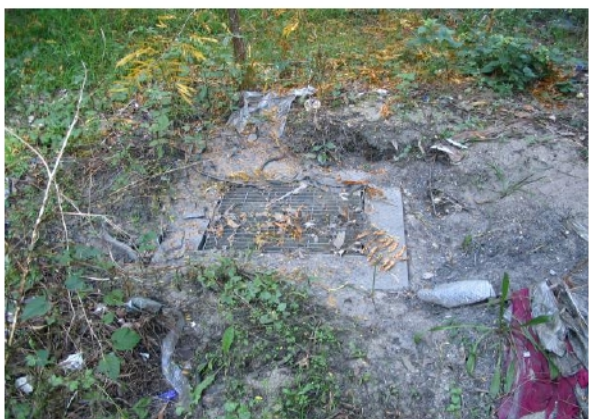
Photo 11 - Surcharge Pit AB4

Large amounts of debris and sediment have been deposited in close proximity to the pit. This material has been transported from higher in the catchment, conveyed within the pipe network through the Humegard™ GPT (AB2a) and the Humeceptor™ OGS (AB3), to be surcharged at pit (AB4). Its deposition adjacent to the Surcharge Pit, demonstrates the inability of the upstream stormwater pollution control devices to adequately control the runoff from the Woronora bridge.
