**SUTHERLAND SHIRE WATERCOURSE
ASSESSMENT & REHABILITATION
PRIORITISATION**

**VOLUME 2
CHAPTER 1**

**BOTANY BAY
CATCHMENT PROFILE**

2012

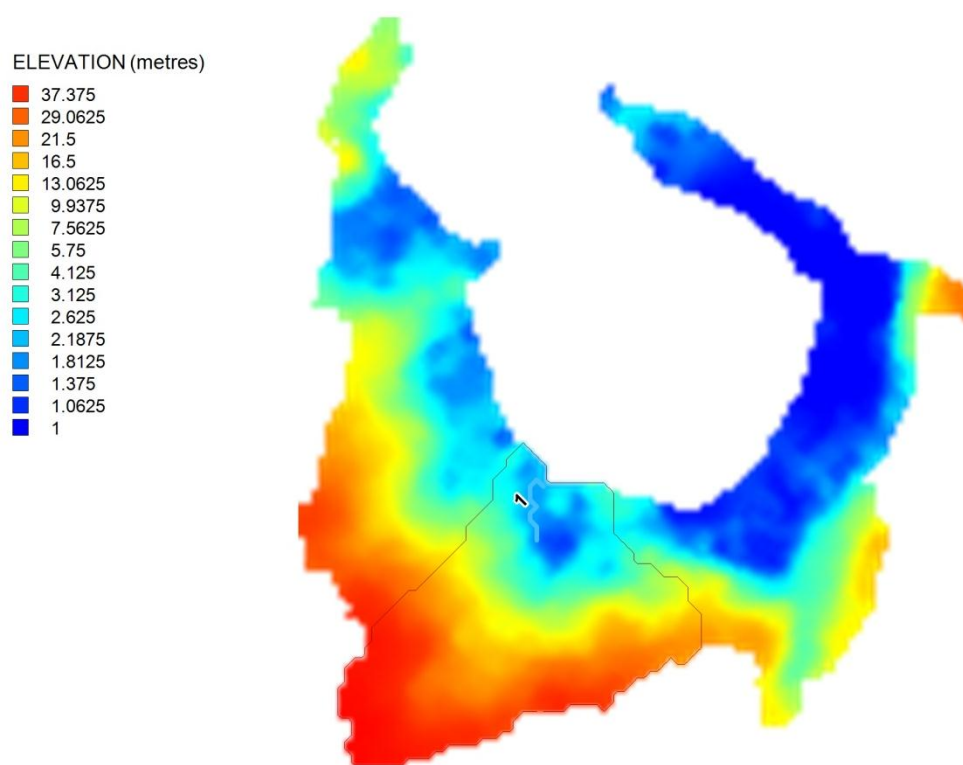
CATCHMENT ELEVATION MODEL: STREAM ORDERS AND CATCHMENT BOUNDARIES

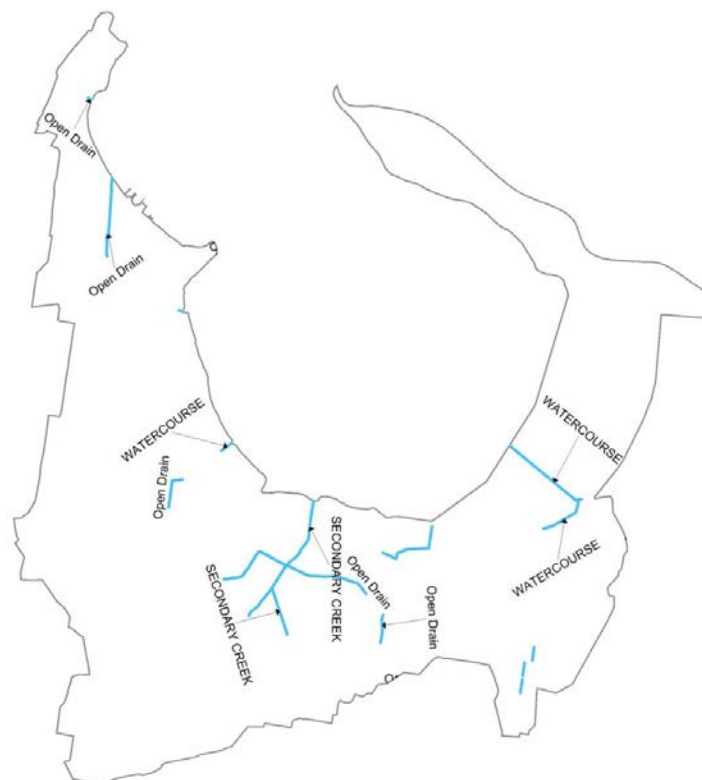
CURRENTLY MAPPED WATERWAYS AND CATCHMENT BOUNDARY

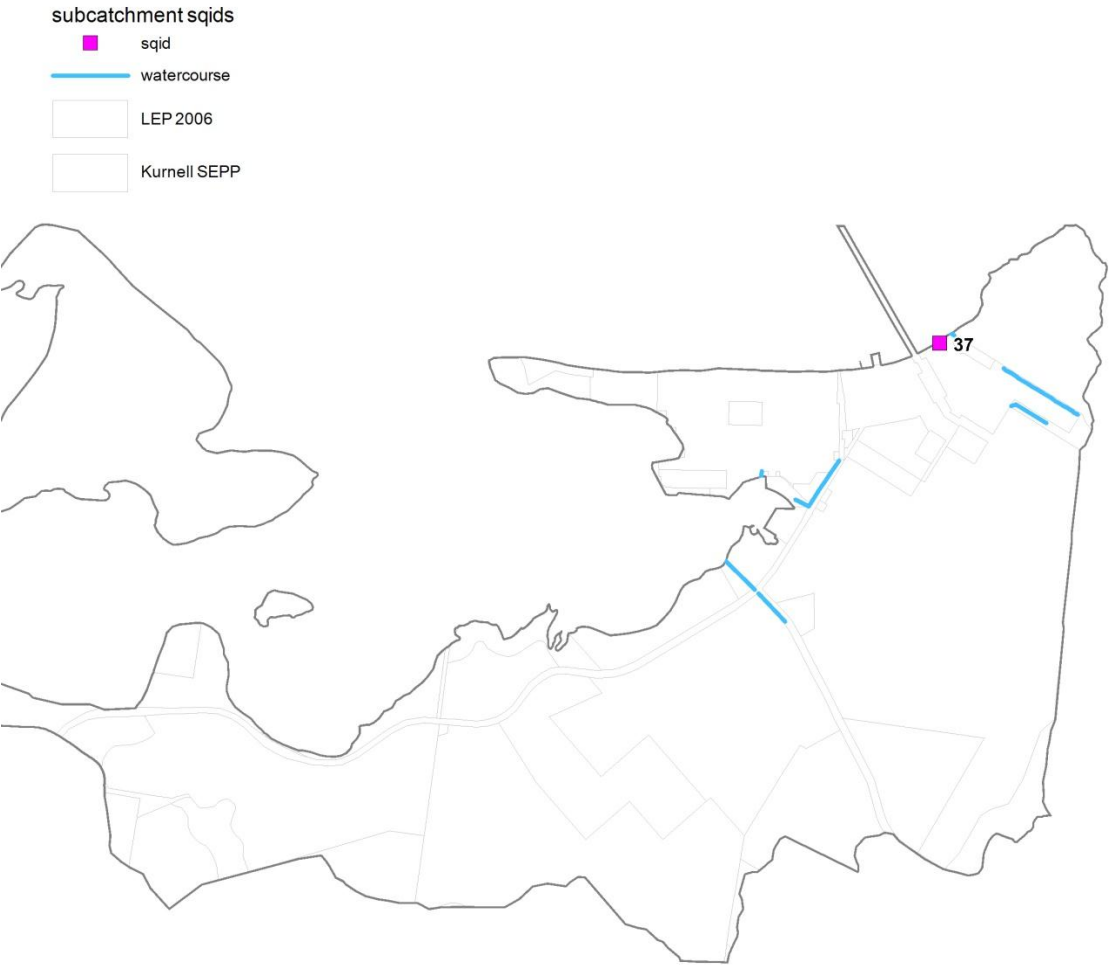
LOCATION OF SQIDS

ID	Device category	Device type	Location	Site description	Suburb	Approx. catchment
37	GPT - Other	Sand Filter	Prince Charles Parade	Silver Beach	Kurnell	1.5 Ha

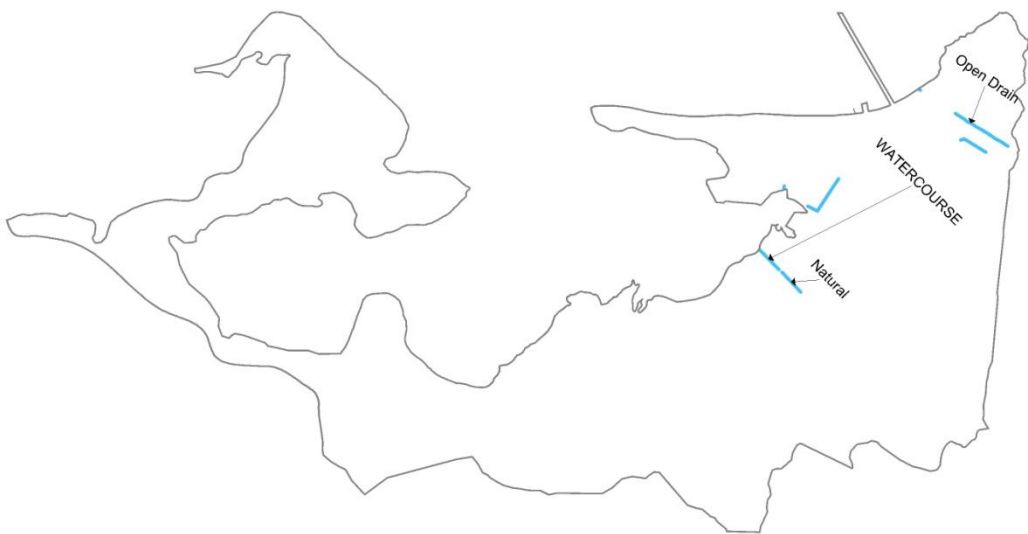
CURRENTLY MAPPED WATERWAYS AND CATCHMENT BOUNDARY
