**SUTHERLAND SHIRE WATERCOURSE
ASSESSMENT & REHABILITATION
PRIORITISATION**

**VOLUME 2
CHAPTER 2**

**GEORGES RIVER
CATCHMENT PROFILE**

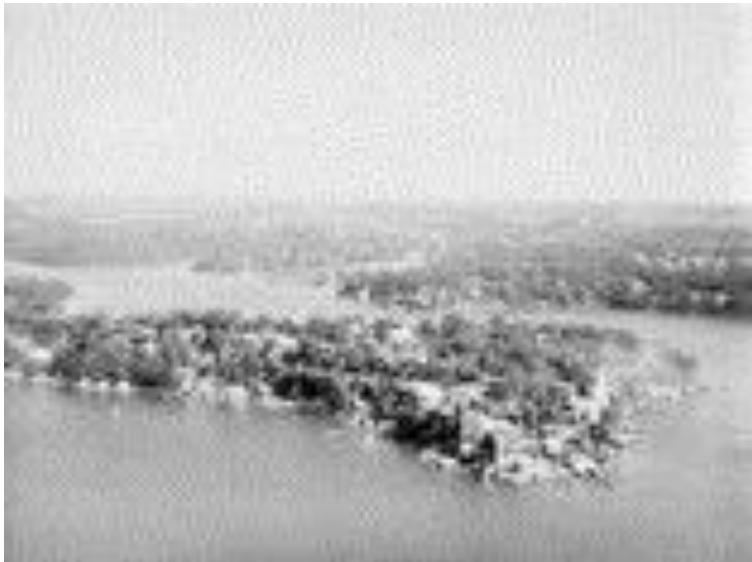
Figure 3. Aerial photo of Kangaroo Point, July 1966.

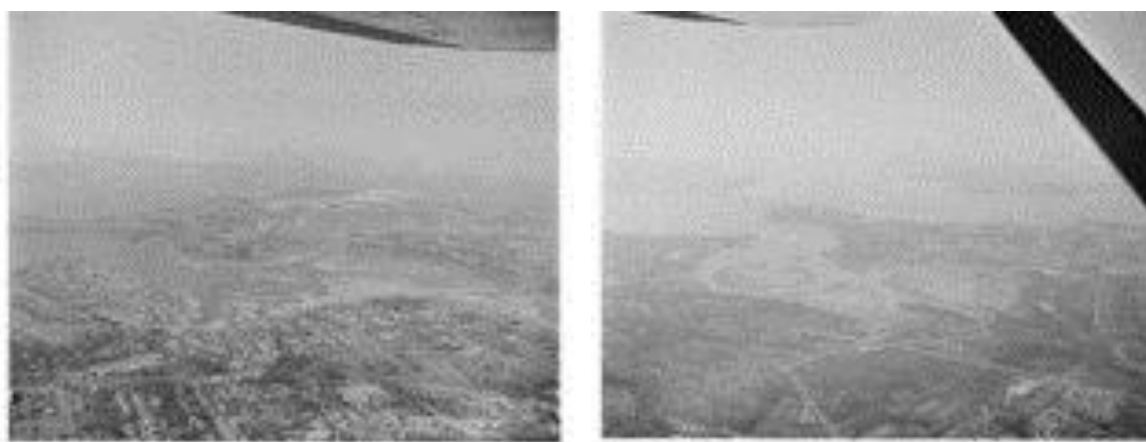
Figure 5. Aerial views of the construction of Sylvania Waters housing estate, July 1965.

Laycock's property was sold to Thomas Holt in 1868, and included most of the land around Sylvania Waters. He built a large sandstone house at Sylvania, named Sutherland House and completed in 1881, shortly before he left Sydney. In Gwawley Bay Thomas Holt planned and excavated a series of canals where he had acquired a freehold of approximately 180 acres of the waters of the bay. The canals were constructed in the marshy foreshores at the head of the bay and were to be used in Holt's oyster cultivation ventures. The canals, all in neat rows, were about 20 feet wide and four feet deep, with about 10 feet between each canal. There were several miles of canals, all emptying into the main channels (Lawrence, 1997).

In the 1920s the bay was owned by an oyster farming family, and then sold in the 1950s before being bought by a development syndicate in 1960. Sylvania Gardens P/L proposed to build a garden suburb, complete with waterways, recreation areas, living, school and industrial sites, roads and shops. Economic pressure resulted in changes to the plans, and three islands were created, all linked to the mainland by bridges and contained behind a five mile long retaining wall. Compared to other parts of the Shire the area has a long history of modification, both hydrological and terrestrial, with much of the catchment area cleared for market gardens and orchards, and small herds of sheep and cattle.
