# PORT HACKING

Past and present of an estuarine environment

## Sutherland, NSW 2013

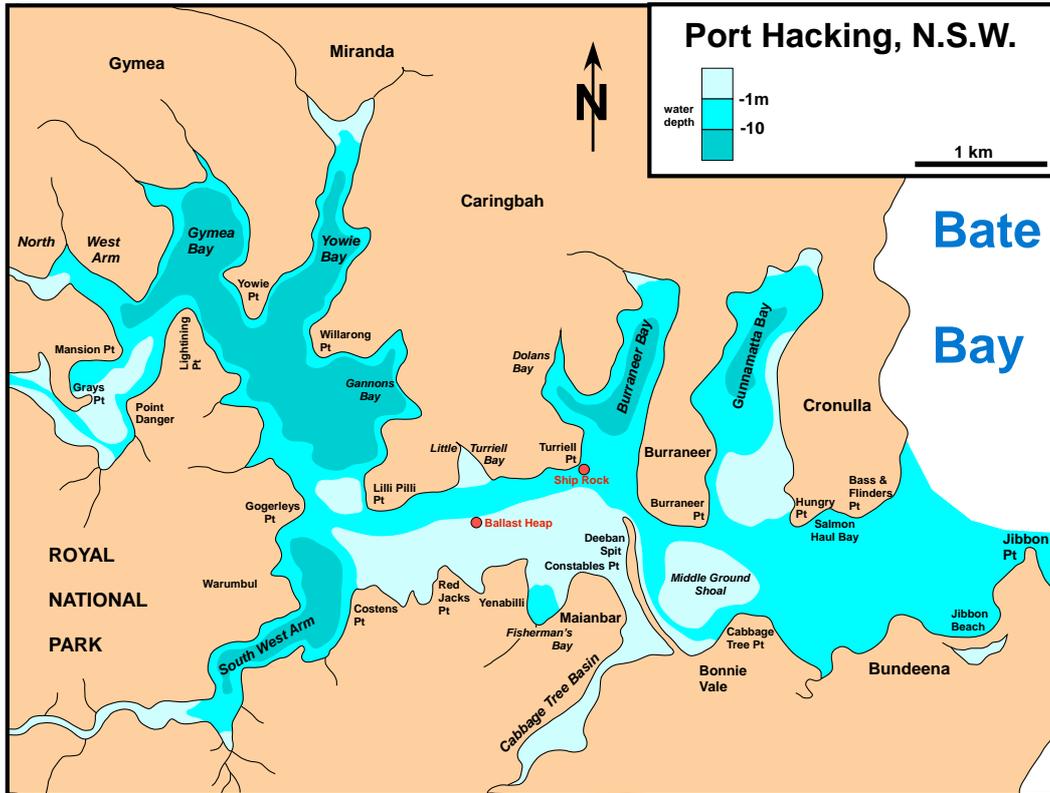
Figure 7 - Bathymetry map of Port Hacking

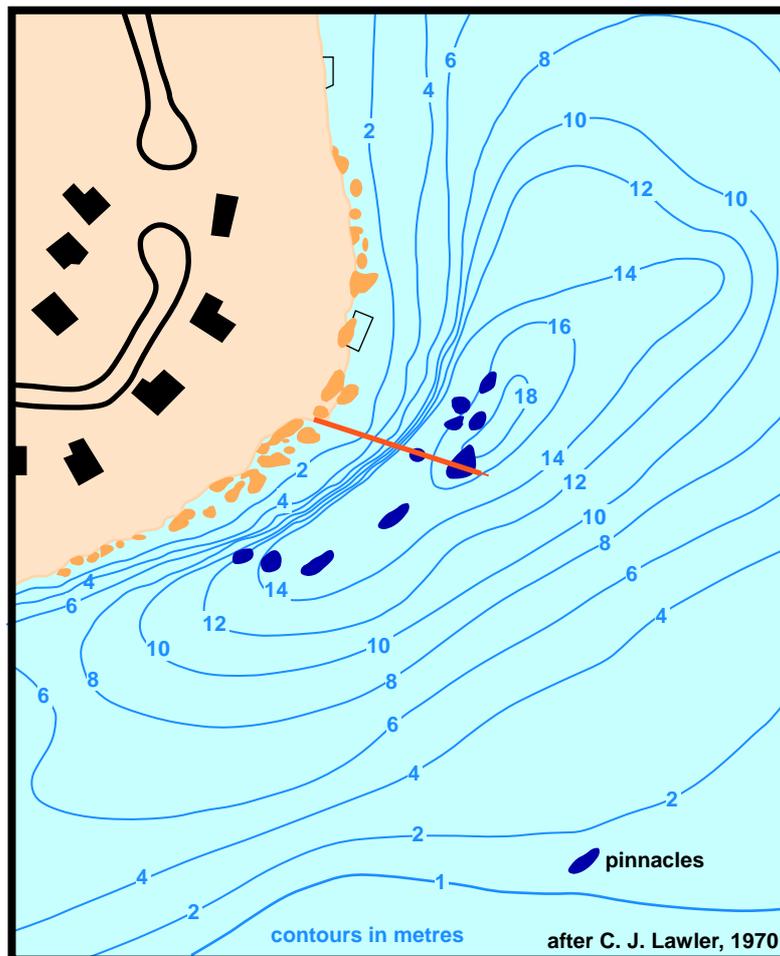
Figure 21 - Depth contour map of the Shiprock Aquatic Reserve

have been found to be superficial, and the currents below the surface (these being critical to the existence of the submarine character) behave differently. The bathymetry (sea-bed contours) (Fig. 21) shows the local peculiarities of the site.

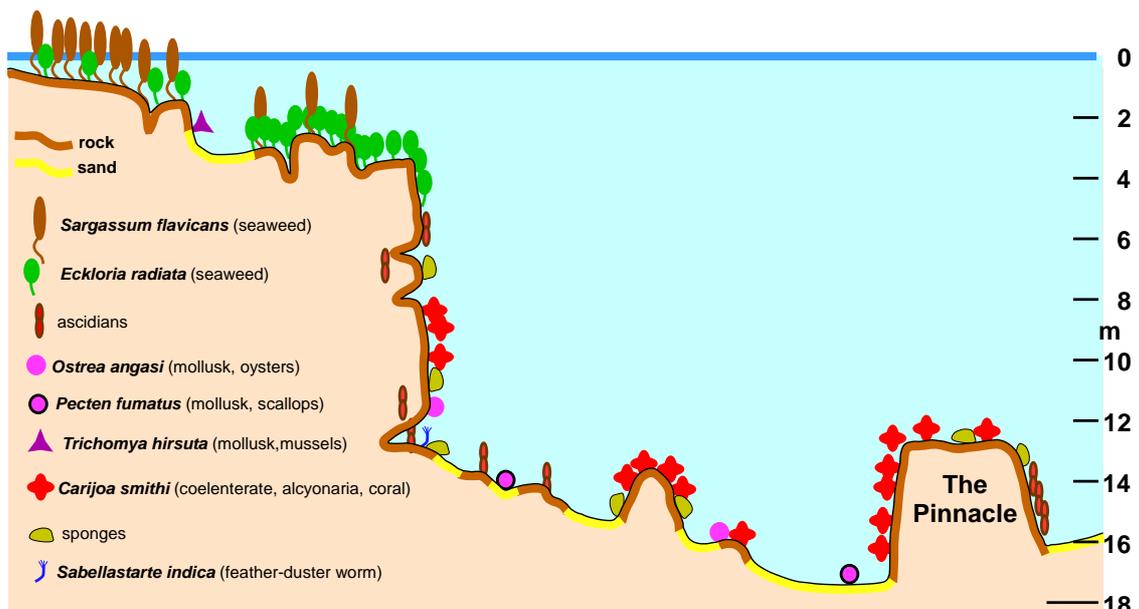
Figure 22 – Idealised section showing the distribution of the most common elements of the biota (redrawn from original by C. Lawler, 1998).

Figure 22 shows the subtidal profile, i.e. the topography of the wall and seabed, together with the organisms that populate the wall.

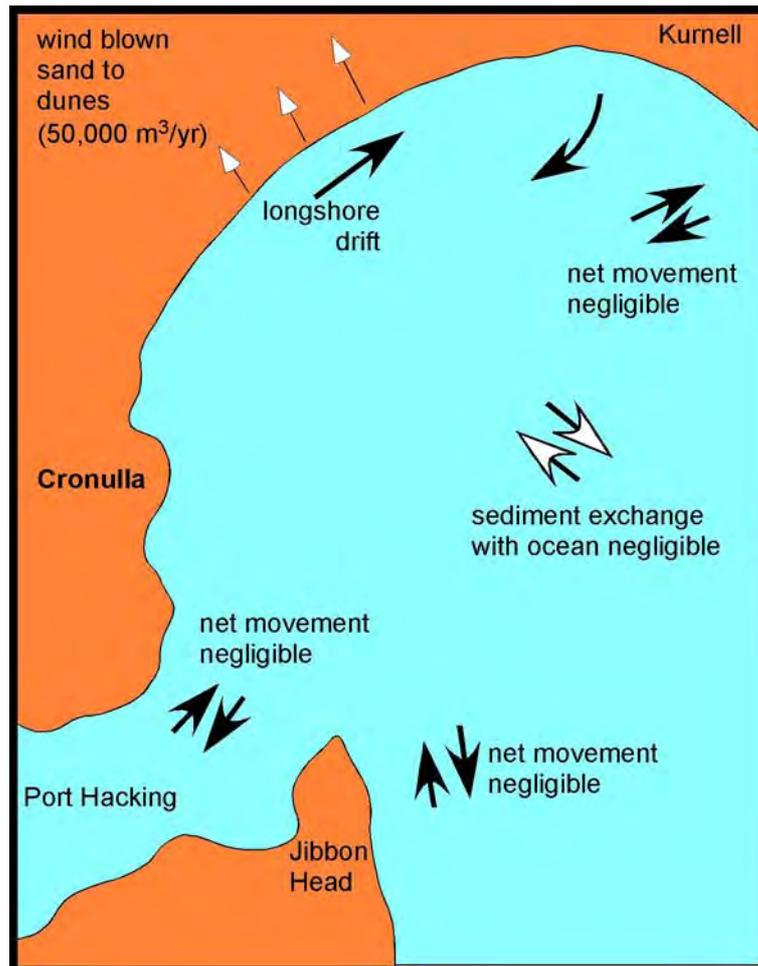
Figure 30 - Energy distribution and sediment movements in Bate Bay (redrawn from *Port Hacking Marine Delta, Management Options*, PWD, 86013)

While a large amount of sand is present offshore, studies have shown that there is now negligible input from the offshore lode to Port Hacking. Therefore, the volume of marine sediment in Port Hacking is near constant (Fig. 30).

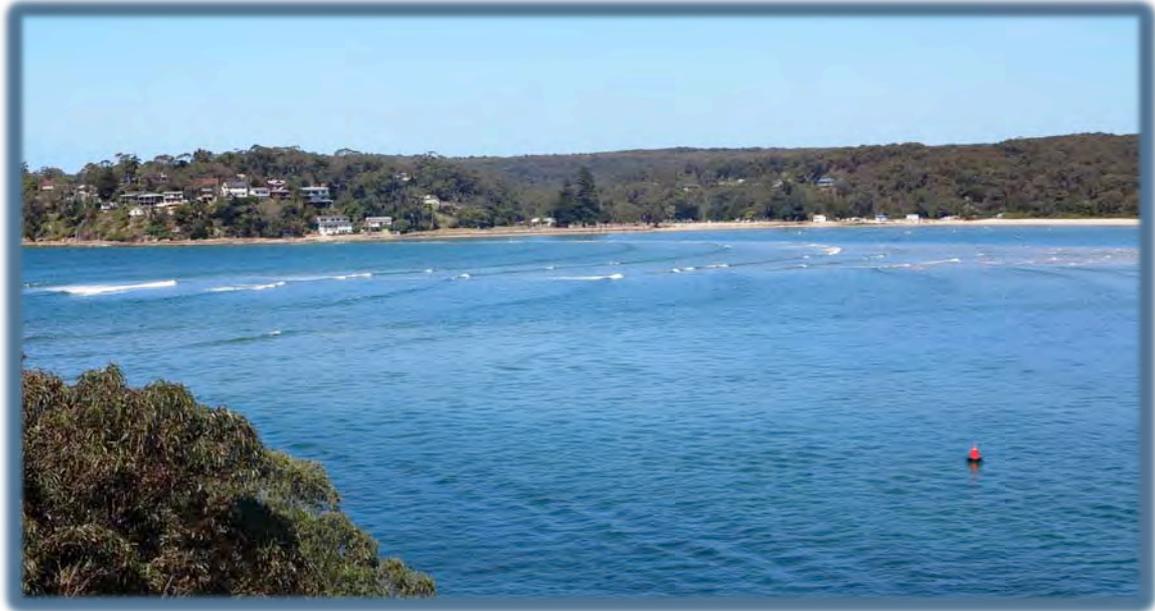
Figure 31 – Simpsons Bay: note the breakers on the middle ground even in calm conditions

However, within the marine delta, waves and tidal currents provide sufficient energy for the redistribution of sediments, in a continuous attempt to reach and maintain a condition of near-equilibrium. Since the early 1900's, sediments have been redistributed by human activities, such as the opening of Cabbage Tree Basin for aquaculture. The dumping of the sediment in Simpsons Bay was the initial formation of the middle ground that grew through subsequent deposition of sand from the various dredging activities for navigation. The very shallow waters at the middle ground show breakers even in a very low swell (Fig. 31).

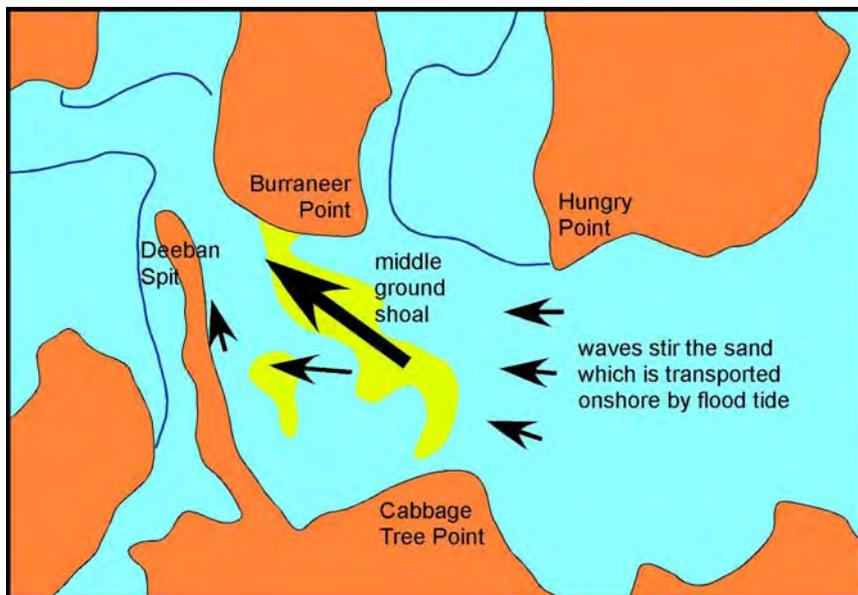
Figure 32 - Energy distribution and sediment movement at the seaward face of the marine delta during flood flows (redrawn from *Port Hacking Marine Delta, Management Options*, PWD, 86013)

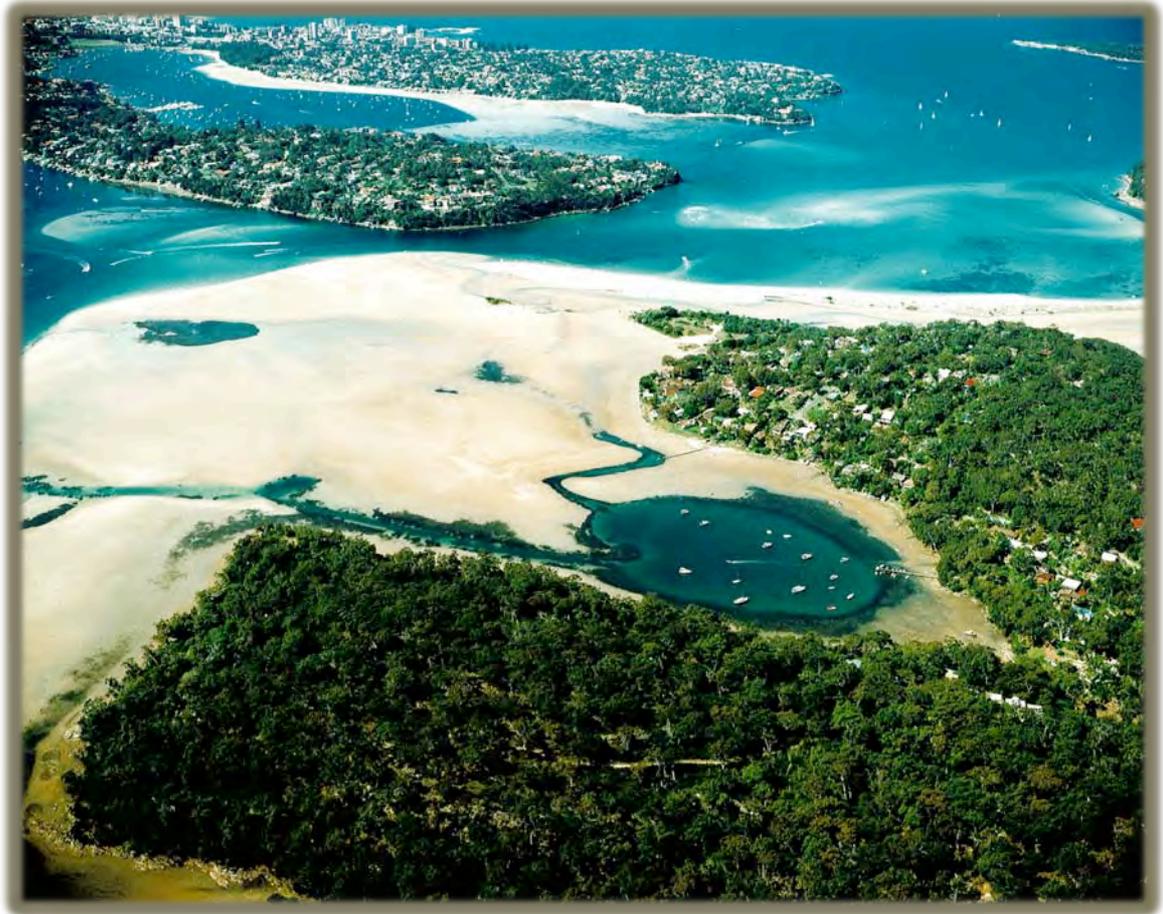
Figure 34 – Fishermans Bay, a sediment locked basin (photo Sutherland Shire Council).

Few areas protected from the waves and tidal currents by the configuration of the ancient valley show limited sediment input and thus relatively deep-water conditions such as Fishermans Bay (Fig. 34).

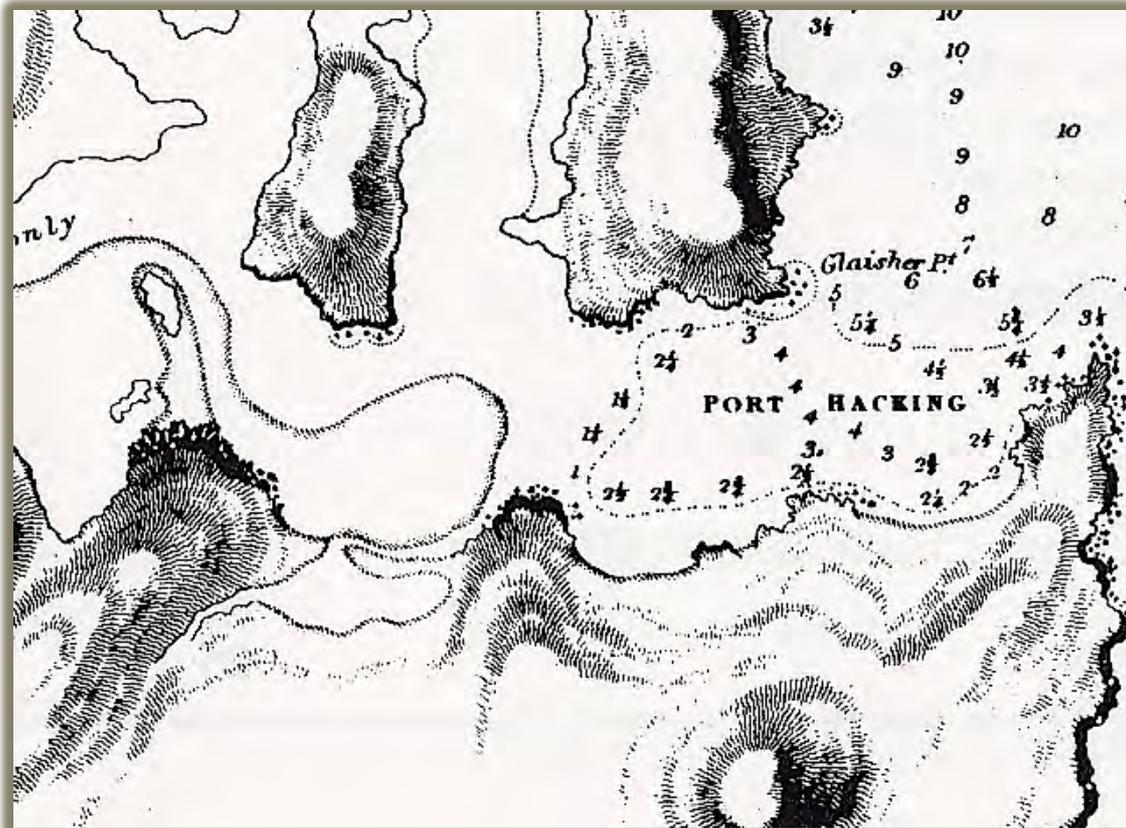
Figure 45 – Portion of the earliest map of Port Hacking (1848-1851 (part) (from *Port Hacking Marine Delta, Management Options*, PWD, 86013). Many significant pre-interference features are evident here, in particular the flow of entry to Cabbage Tree Basin, which begins at Cabbage Tree Point.

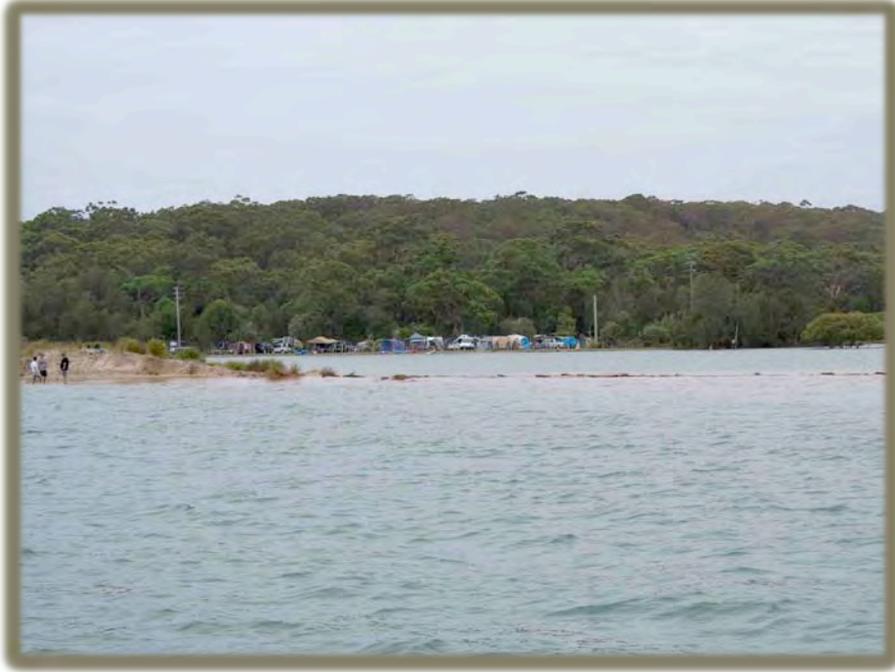
Figure 50 – Break through on 2.24m tide (3/01/2014) to the Bonnie Vale lagoon

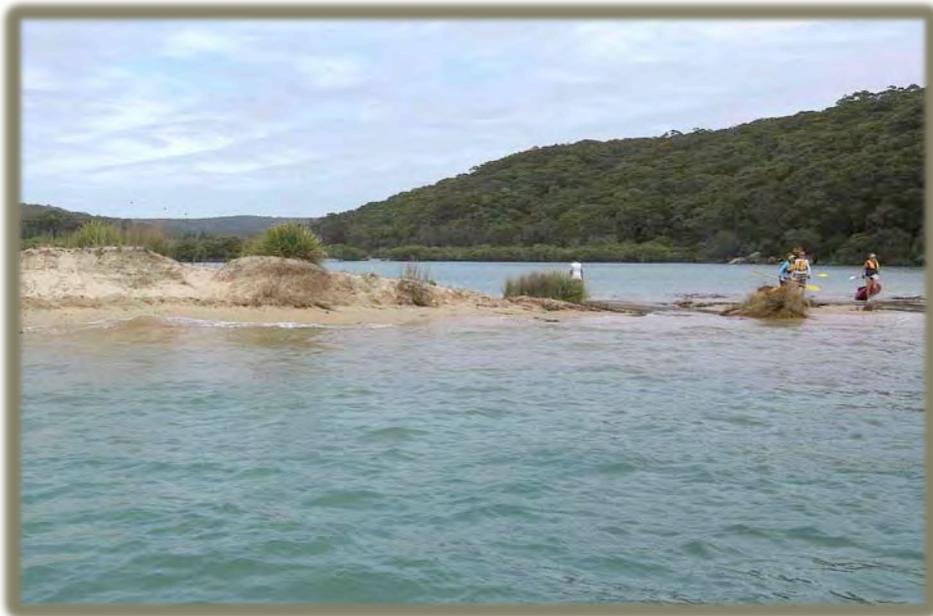
Figure 51 – Break through on 2.24m tide (3/01/2014) to the Bonnie Vale lagoon; The Basin in the background

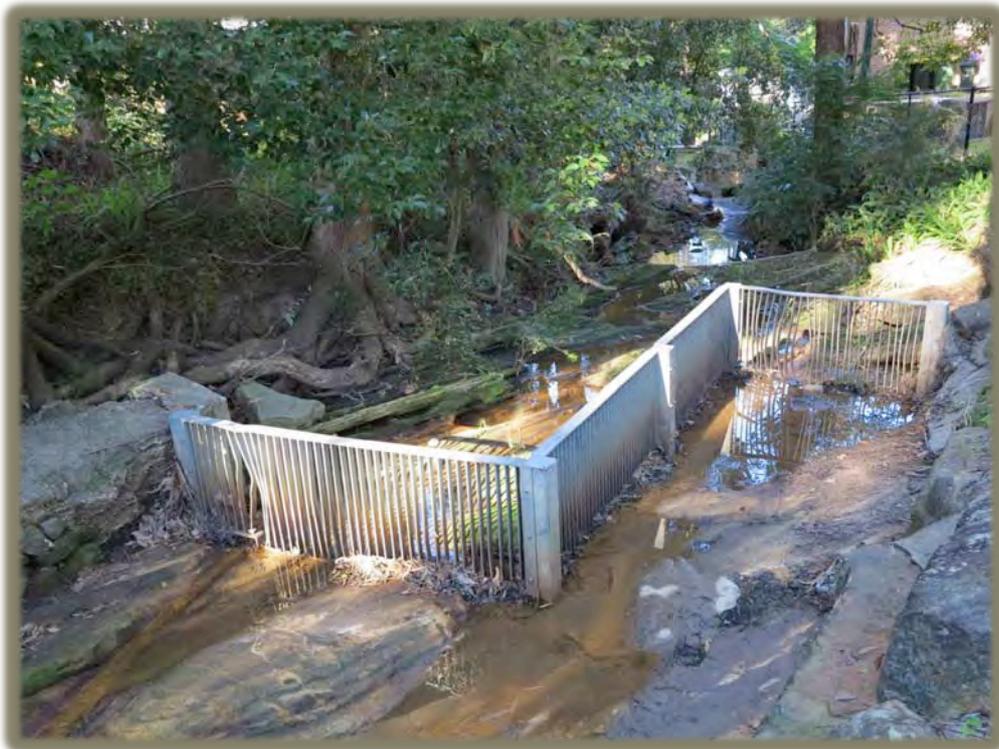
Figure 59 - Trash racks on Alkaringa Creek at Forest Road, Gymea Bay

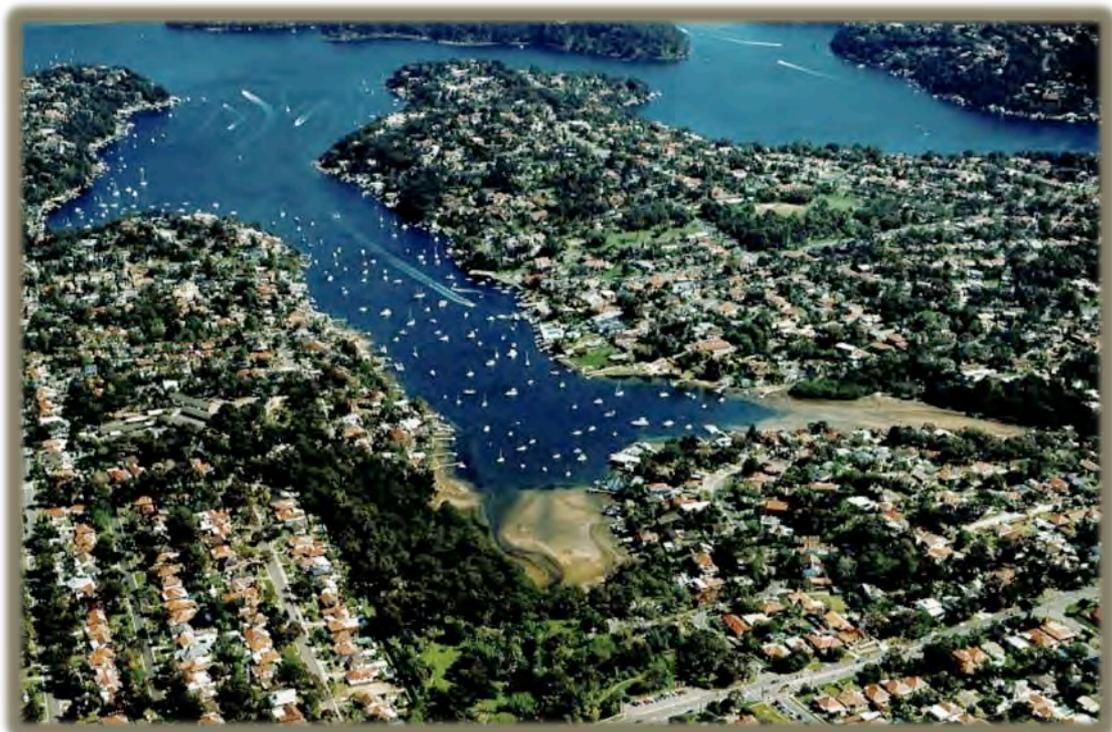
Figure 62 - Yowie Bay. The fluvial deltas are visible at the bottom centre and right (photo Sutherland Shire Council).

The rate of growth and the extent of these deltas depend on activities in, and the conditions of each catchment, such as at Yowie Bay (Fig. 62), in North West Arm (Fig. 63), Gymea Bay (Fig. 64) and South West Arm (Fig. 65).

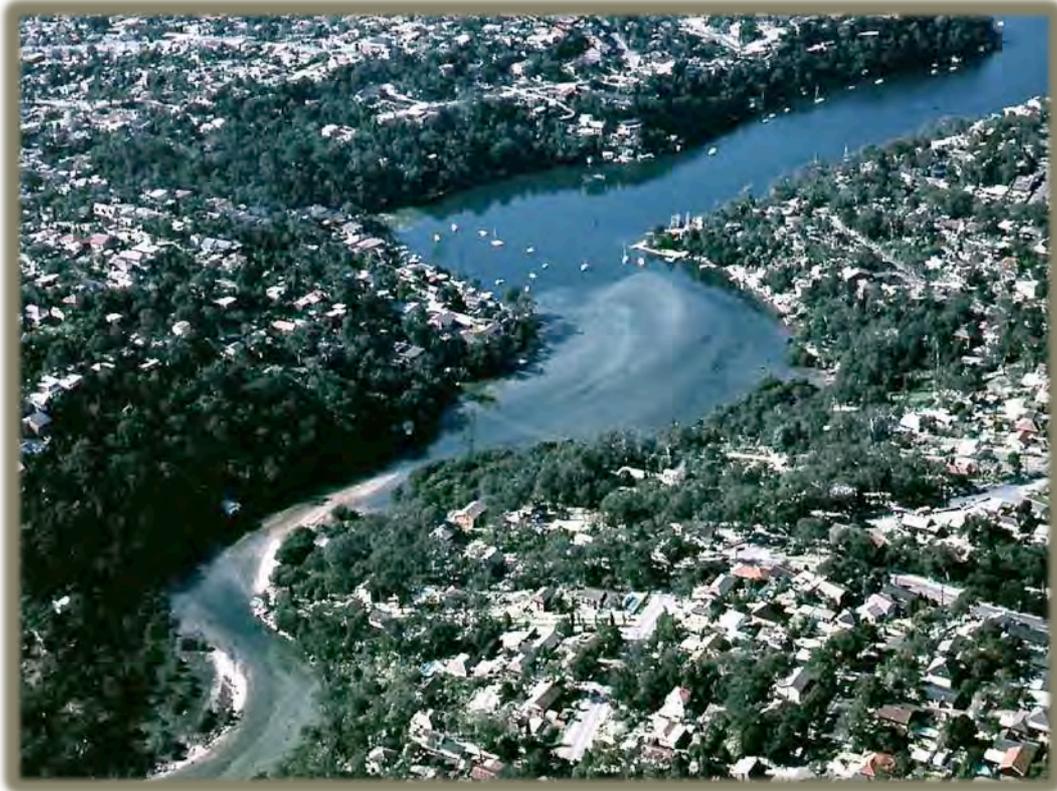
Figure 63 - The fluvial delta present in North West Arm (photo Sutherland Shire Council).

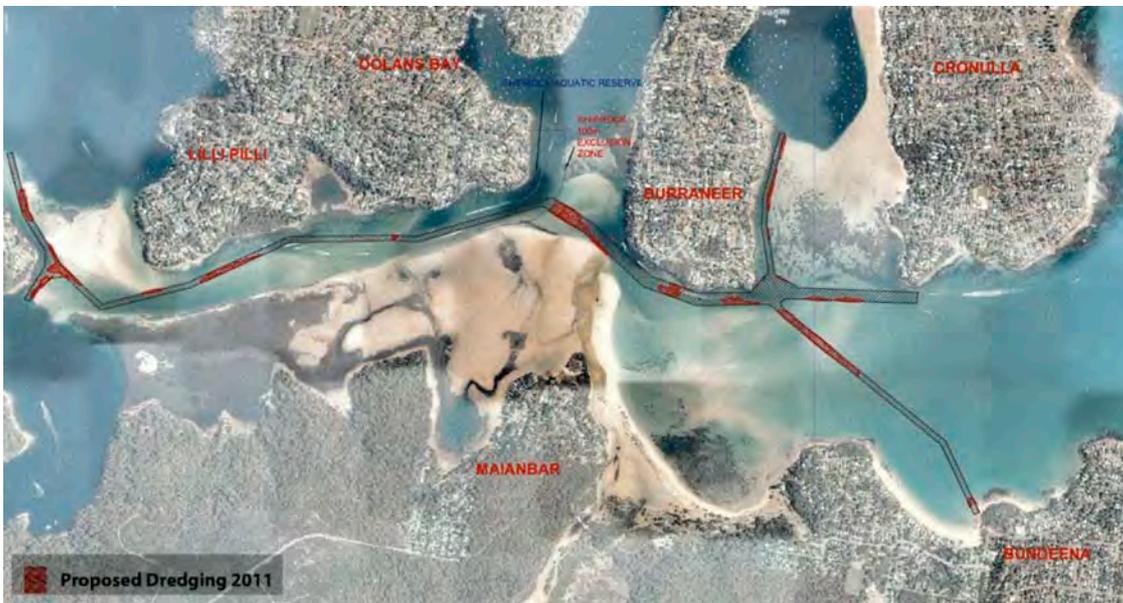
Figure 93 – The 2011 proposed dredging to maintain the channels' viability. (SSC map)

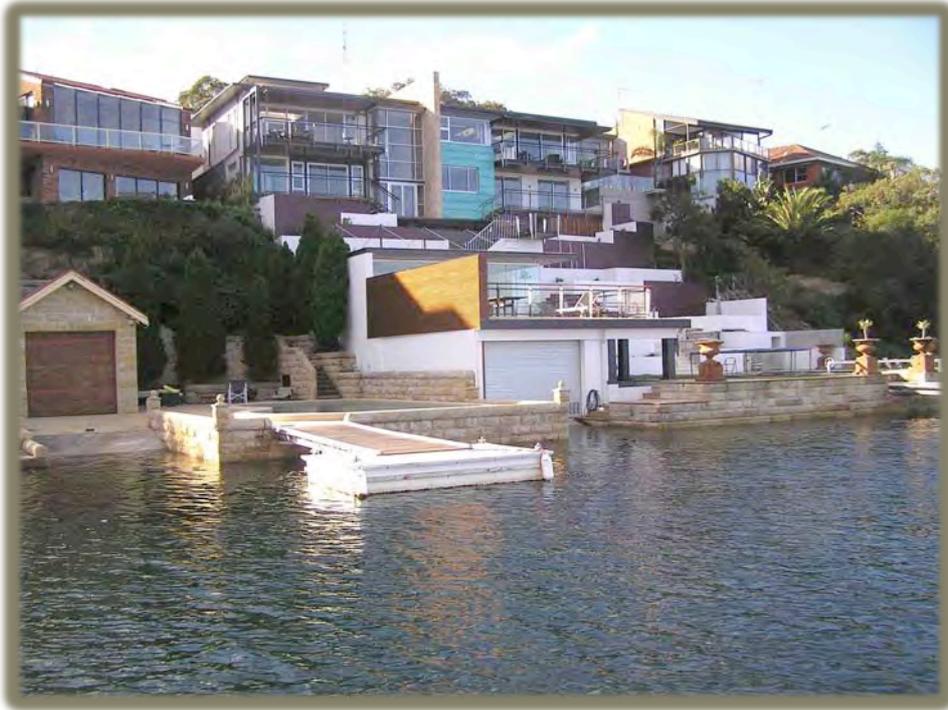
Figure 109 - Artificial seawall.

This has not been without its costs. Vegetation losses have been significant and measurable. The natural terrain has been significantly altered, and the natural water's edge has in too many places been replaced with seawall (Fig. 109).

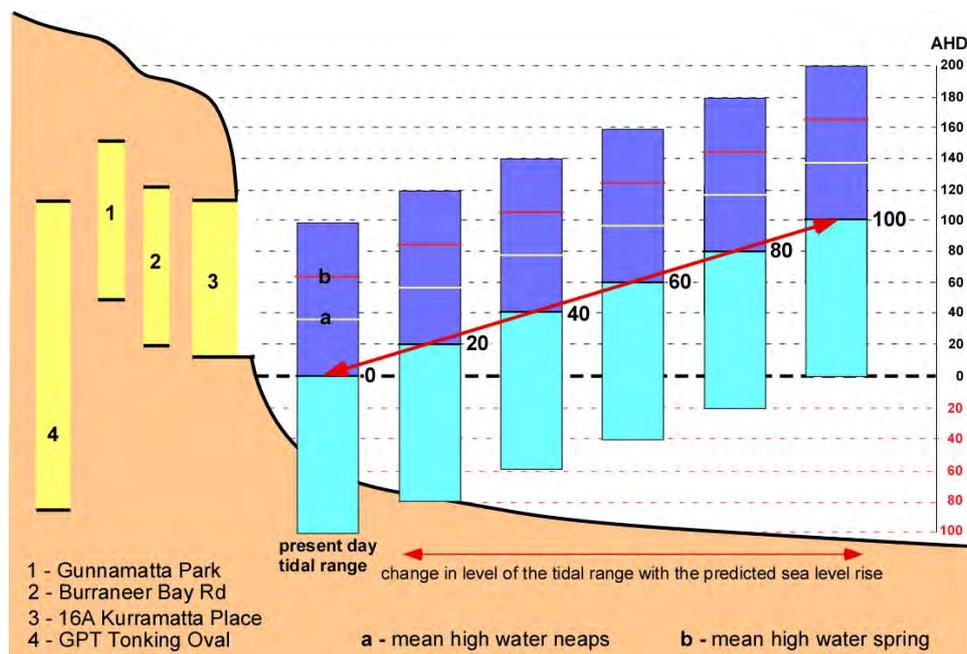
Figure 126 - Potential effect of the rising in sea level demonstrated at some stormwater outlets in Port Hacking

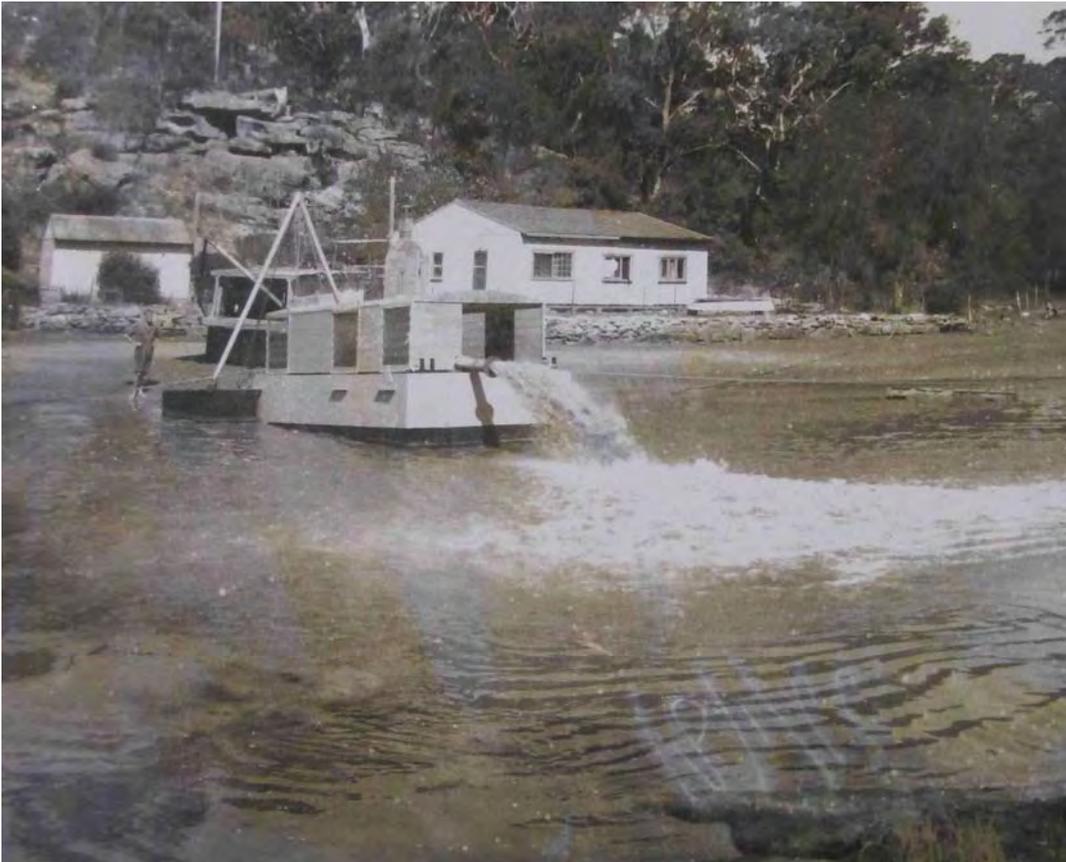
Figure 6 – Dredge in operation in North West Arm (Sutherland Shire Council records)

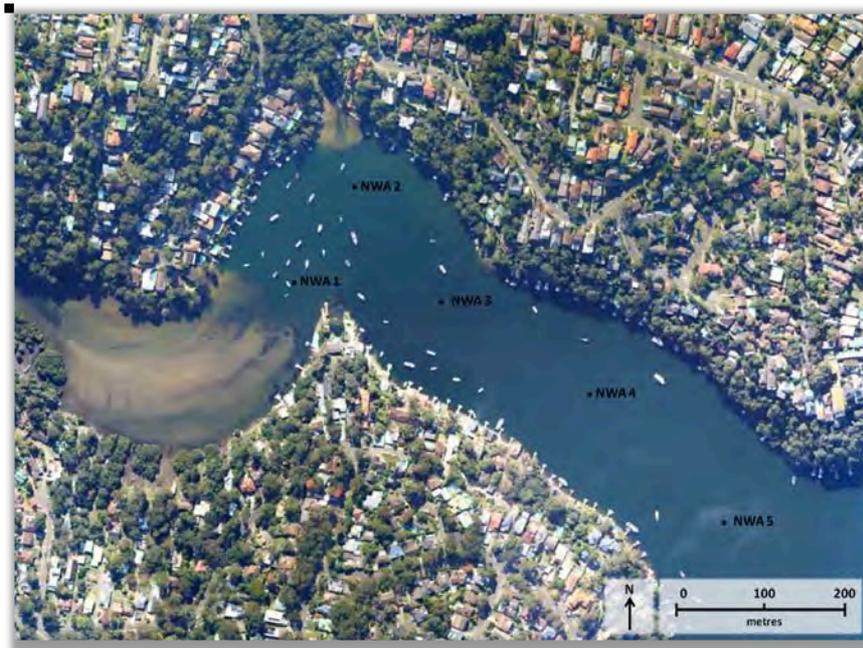
Figure 12 - Location of surface samples from the deep water region of North West Arm.

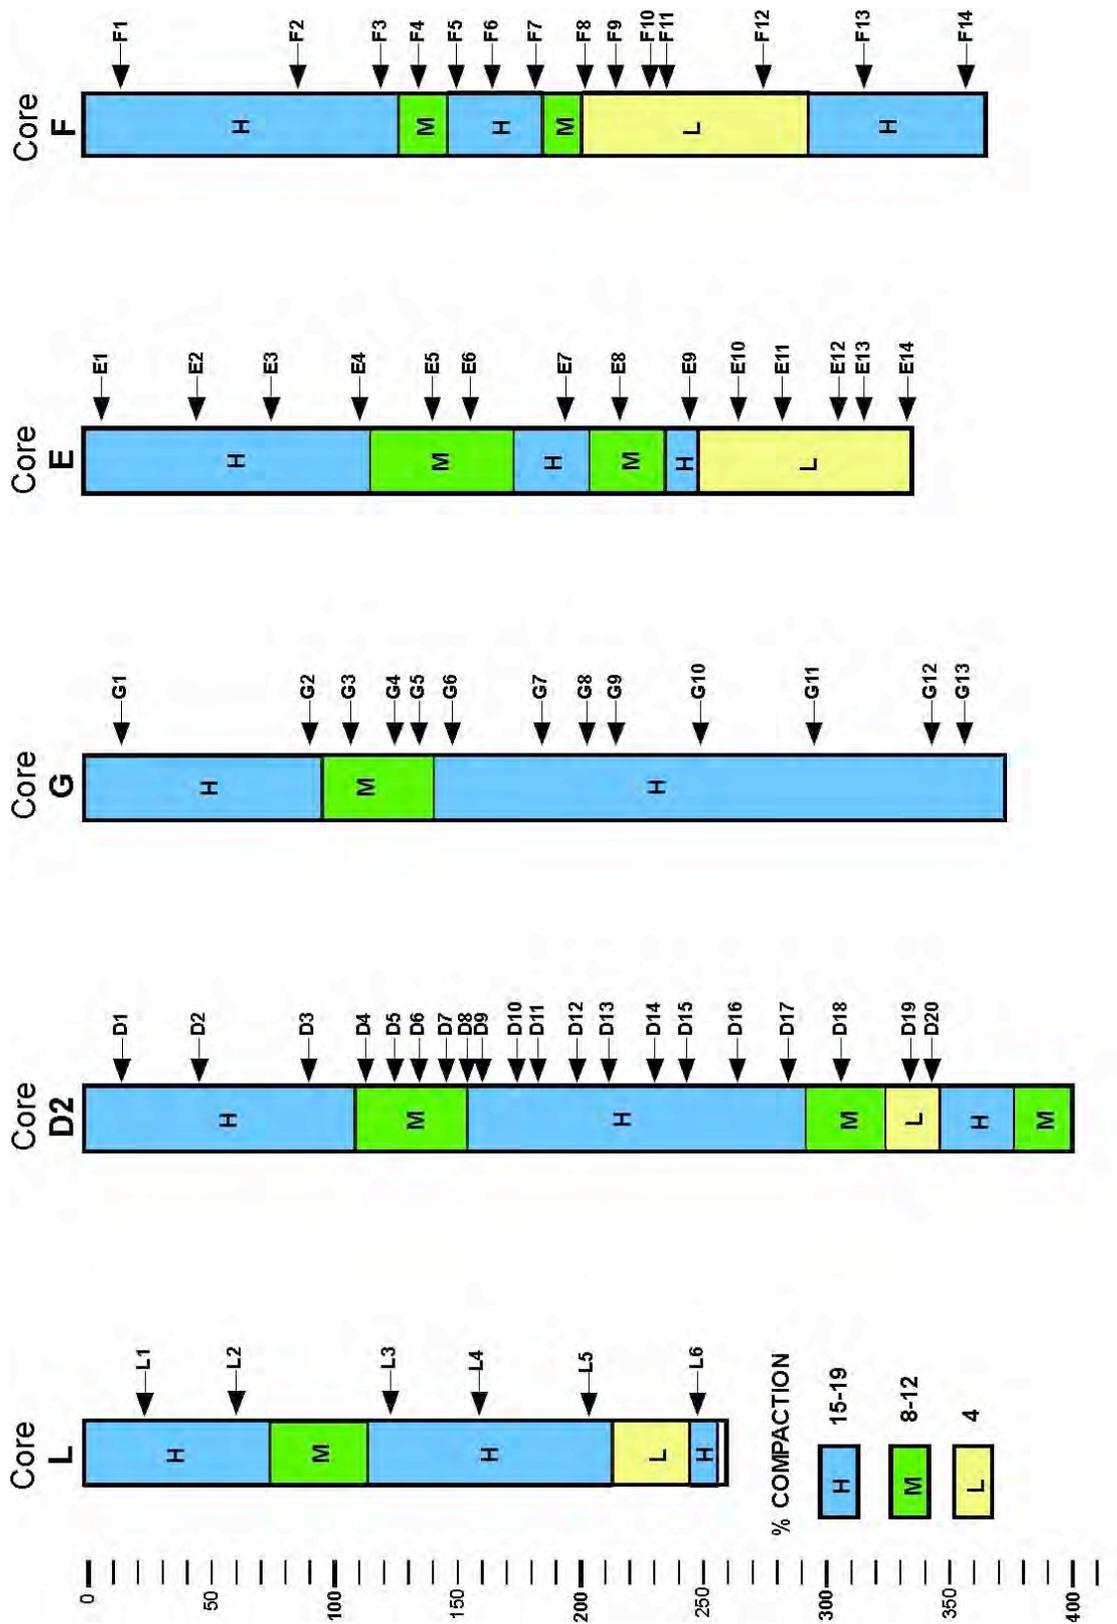
Figure 16 – The compaction rates in each core.

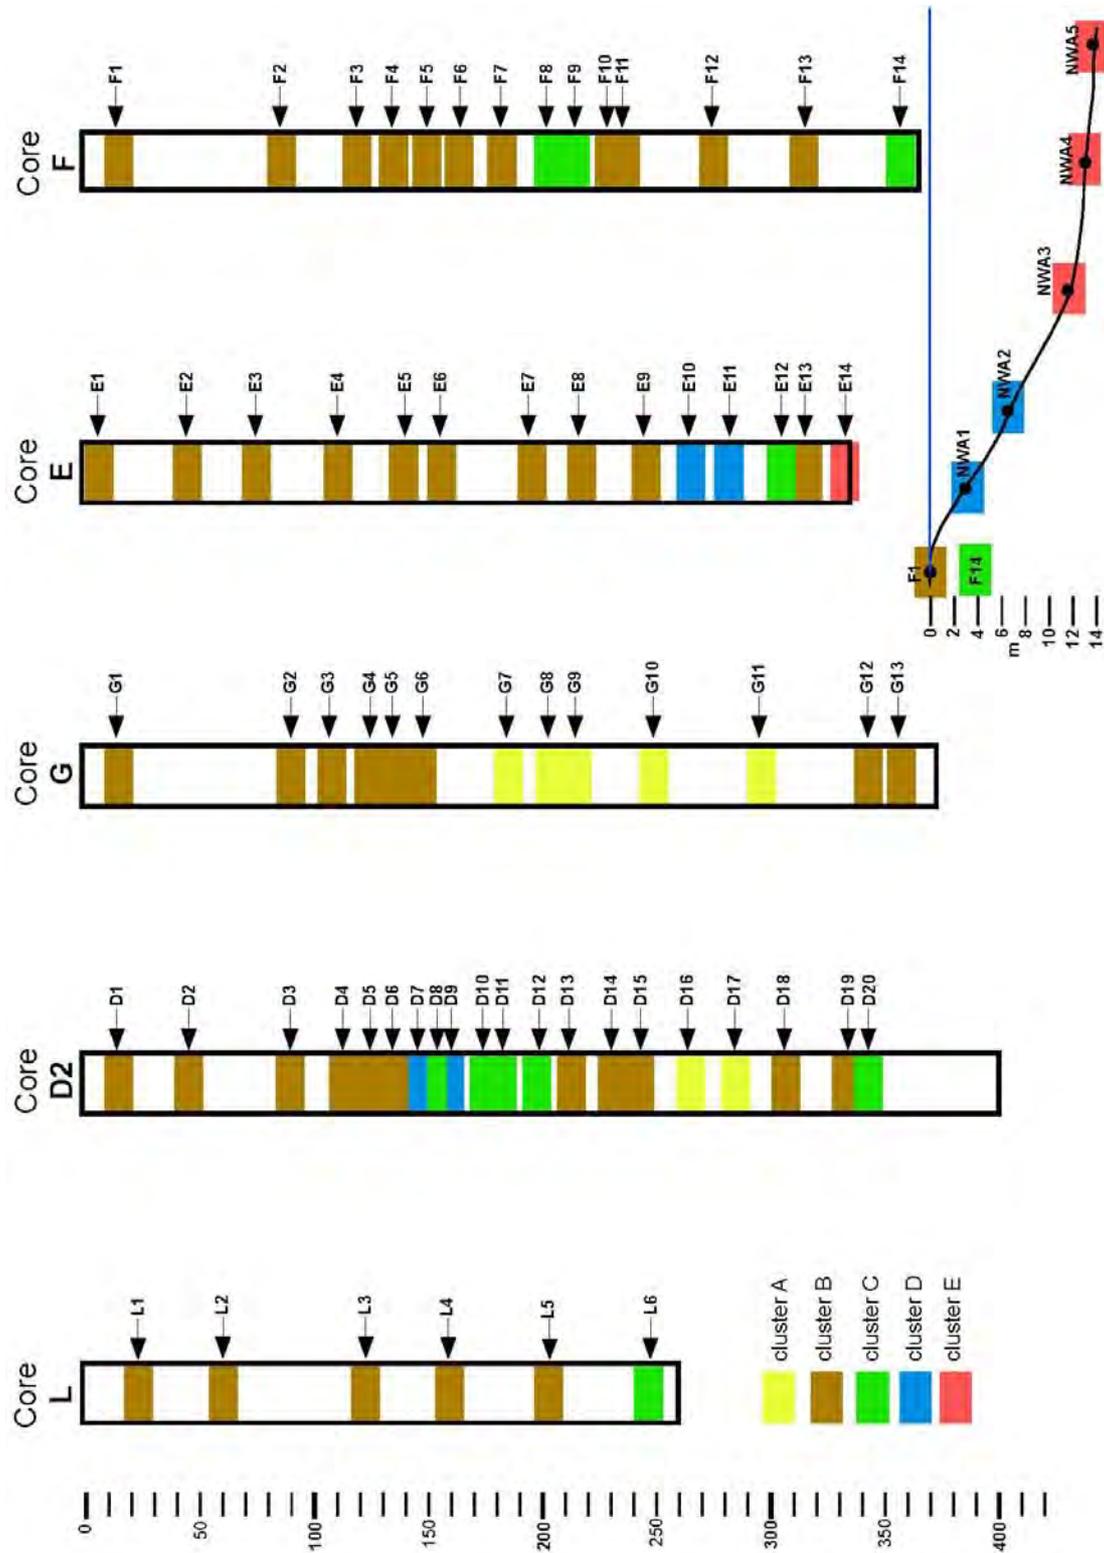
Figure 19 - Distribution of the clusters in the cores

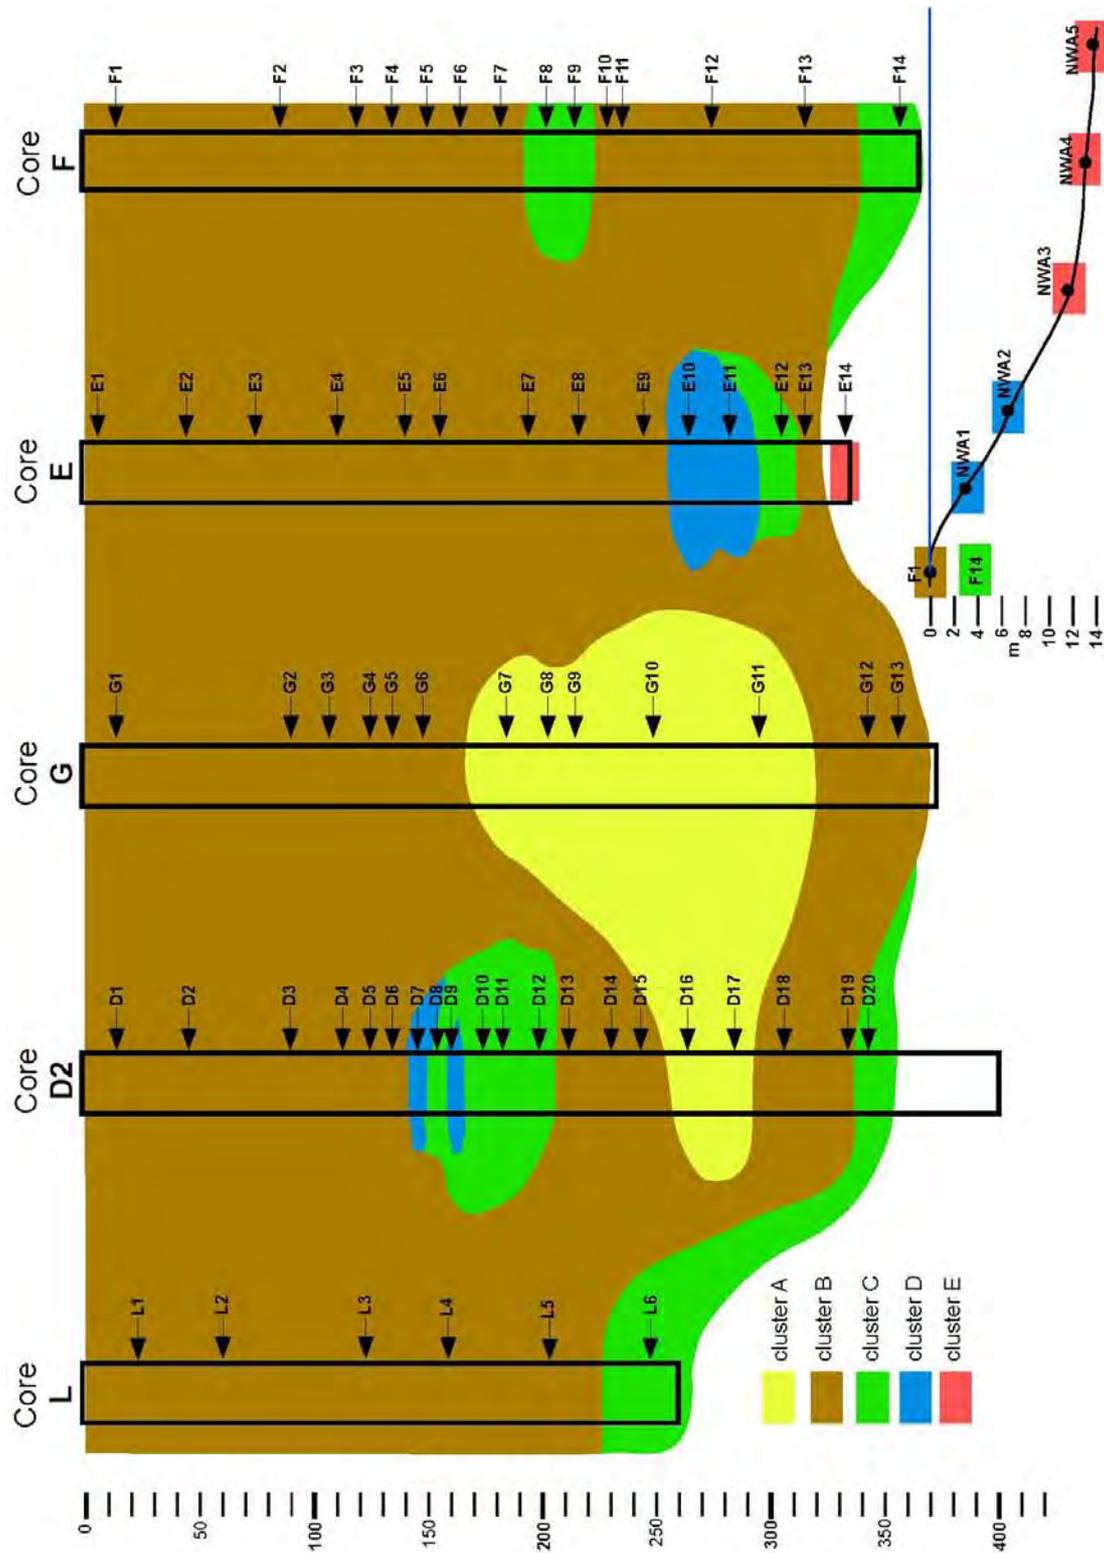
Figure 20 – Sediment correlation along the section

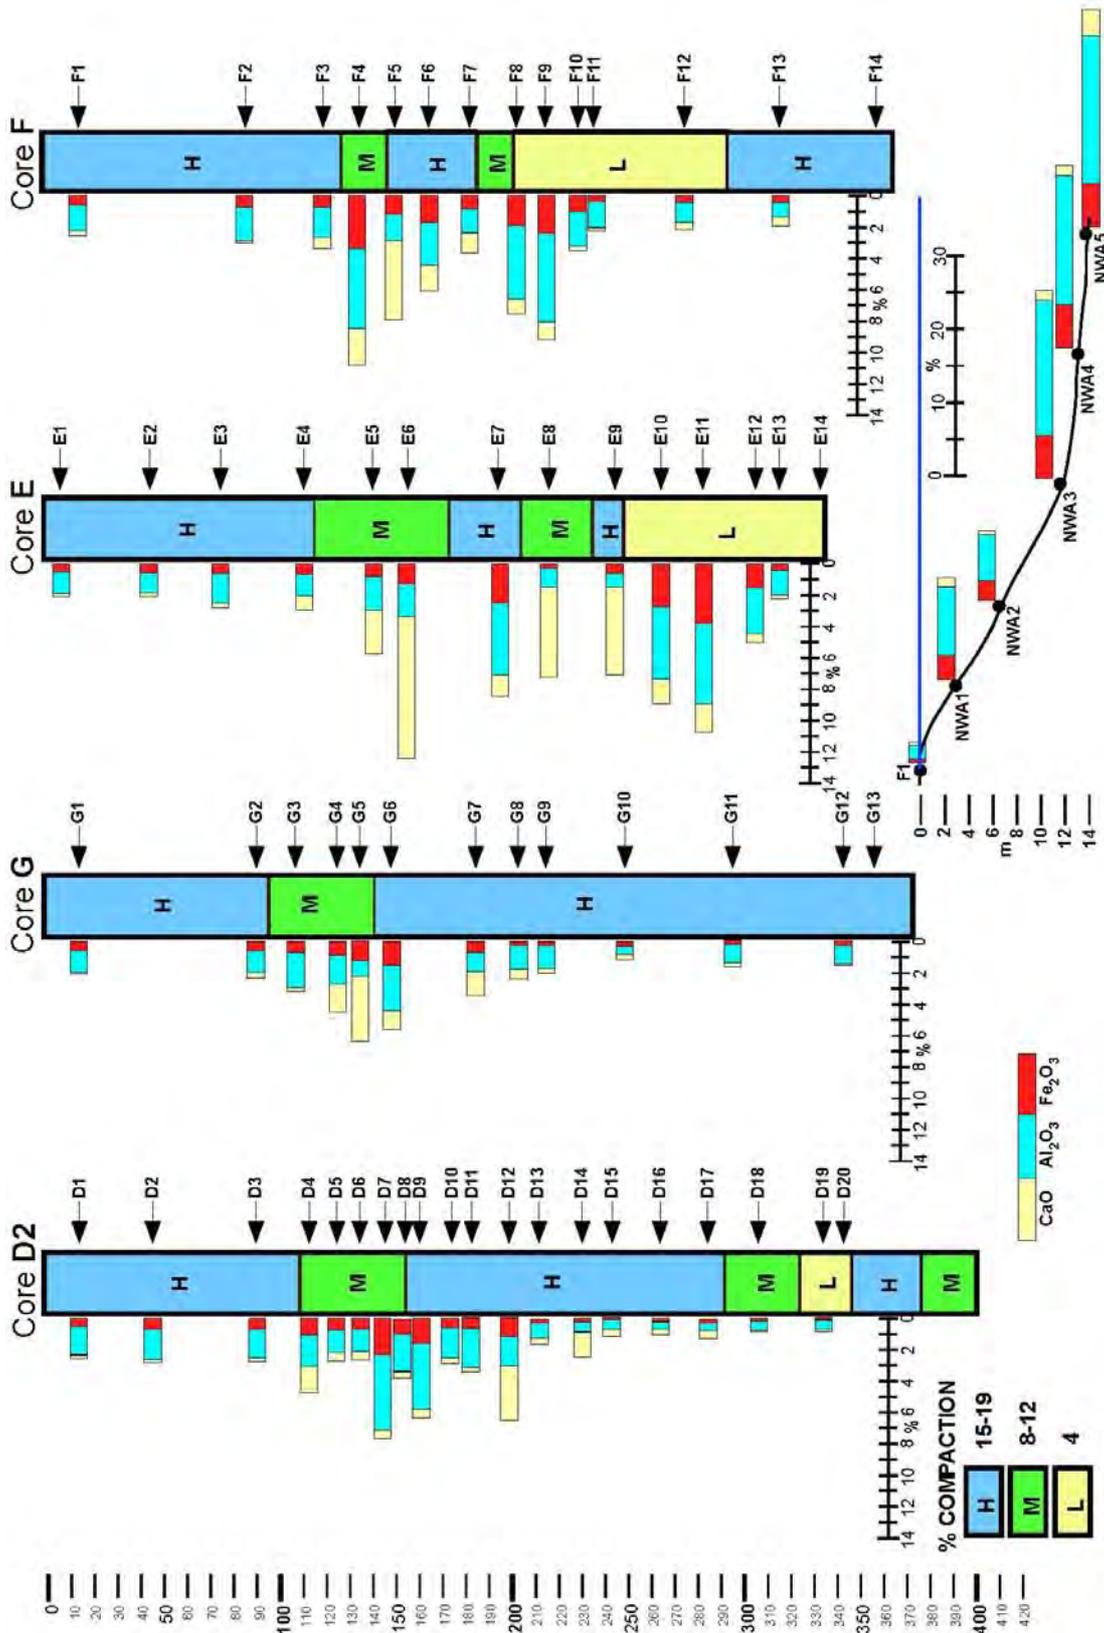
Figure 21 – Concentration of CaO, Al<sub>2</sub>O<sub>3</sub> and Fe<sub>2</sub>O<sub>3</sub>

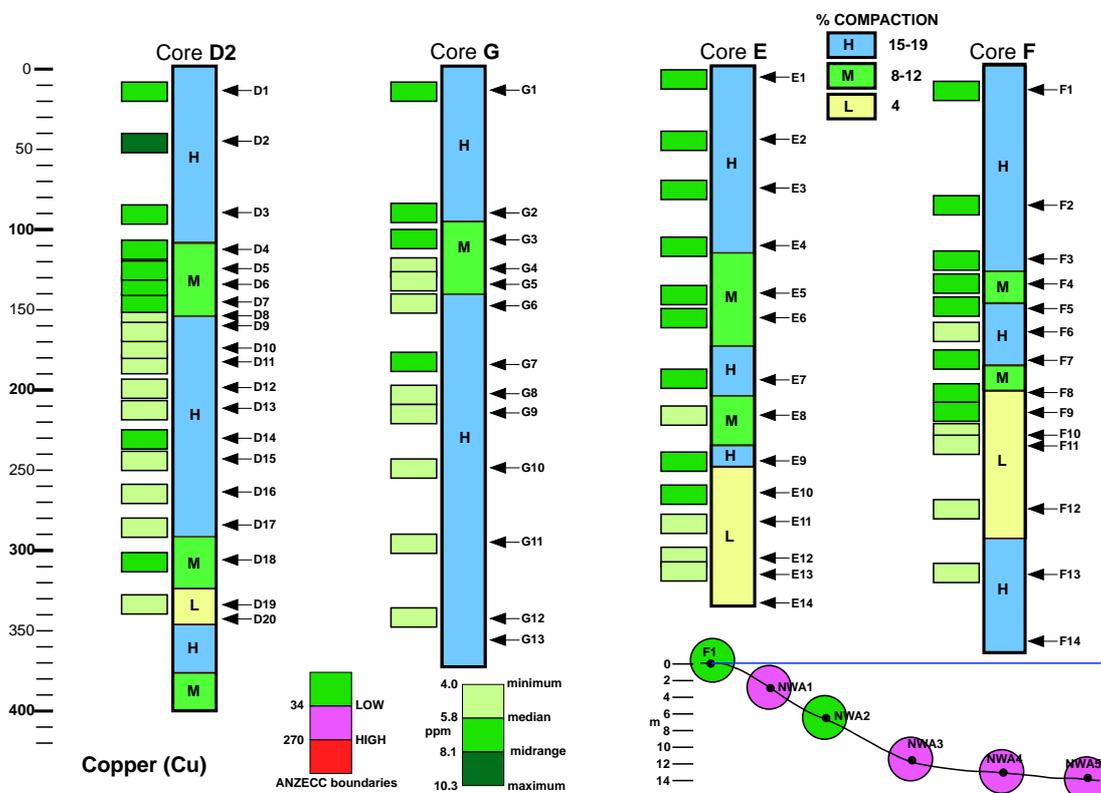
Figure 23 – Distribution of the concentration of Copper

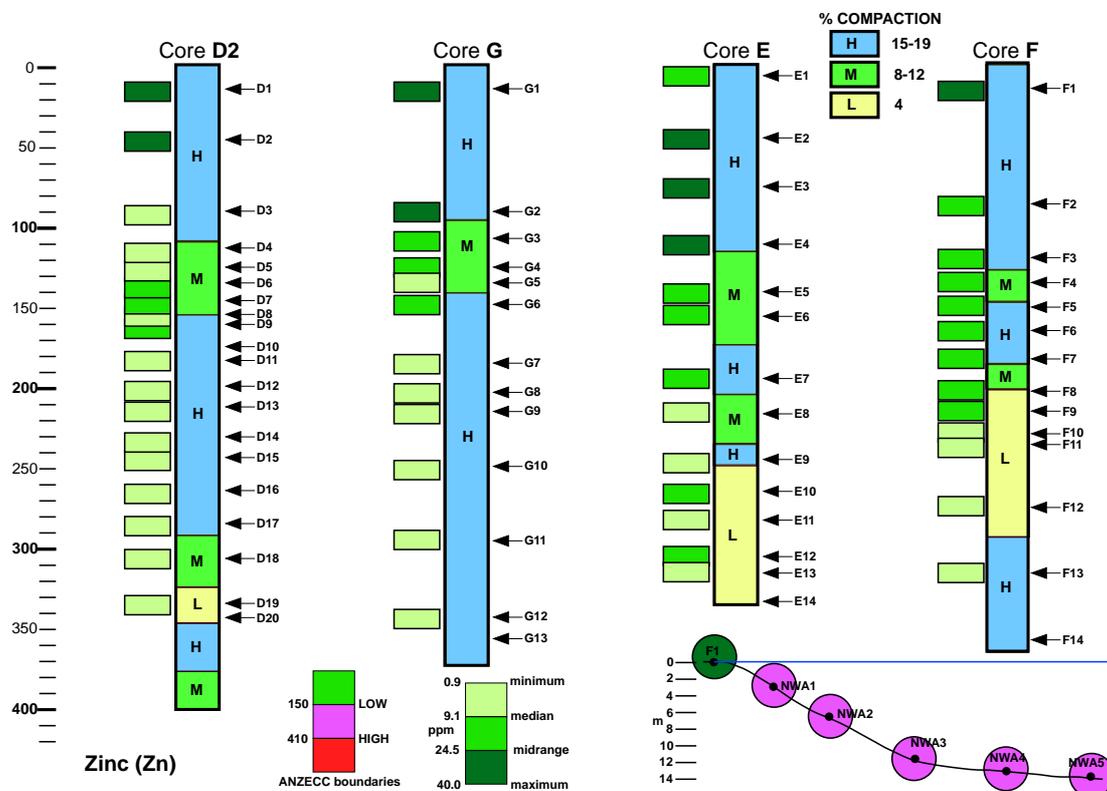
Figure 25 – Distribution of the concentration of Zinc

#### d. Zinc (Zn) (Fig. 25)
