# PORT HACKING

Past and present of an estuarine environment

## Sutherland, NSW 2013

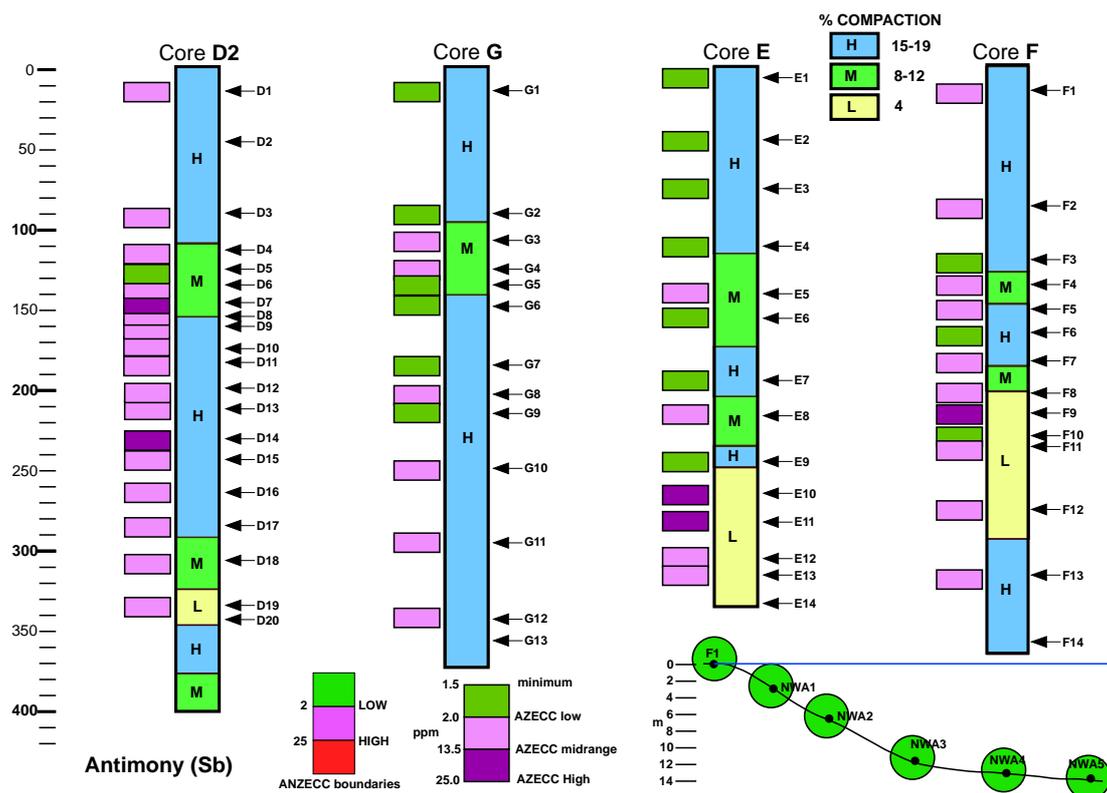
Figure 27 – Distribution of the concentration of Antimony

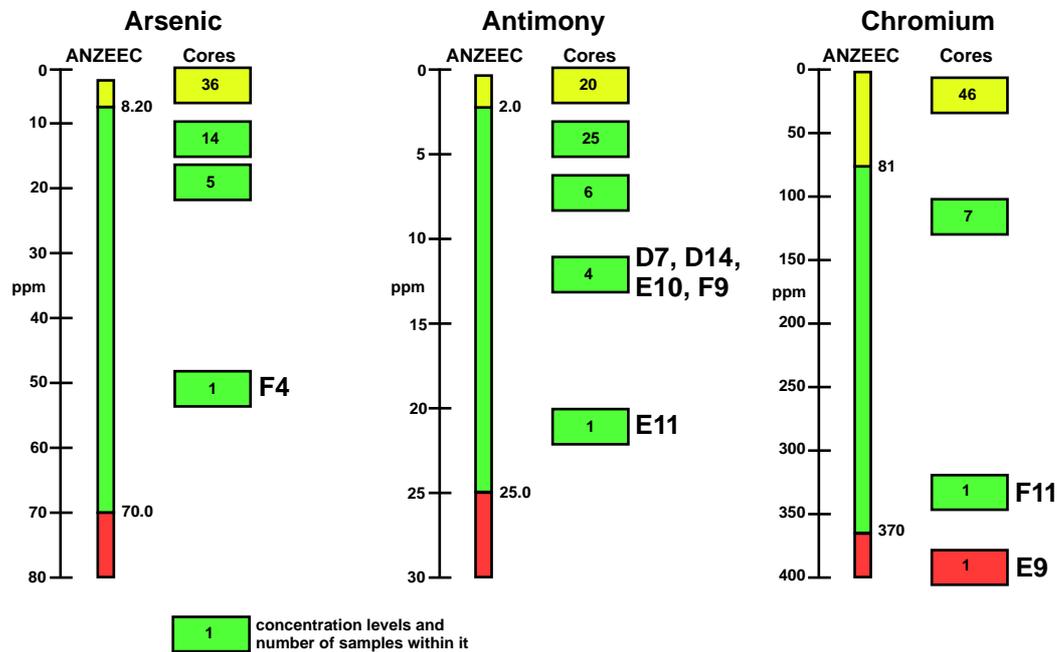
Figure 28 – Summary of the concentrations of Arsenic, Antimony and Chromium

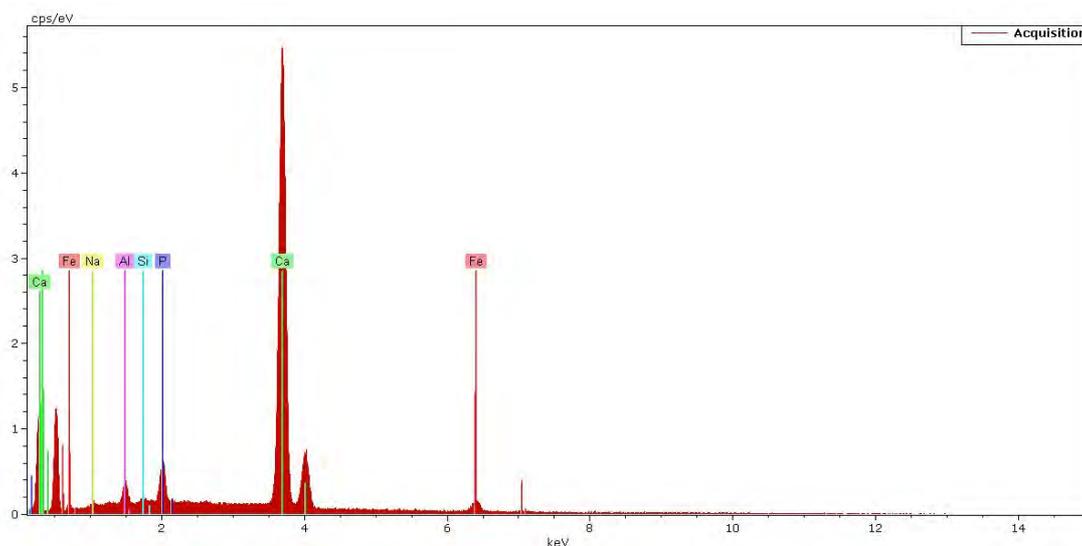
Figure 32 - Peak elements Ca, P and Fe detected in Figures 3.20 and 3.21.
