**SUTHERLAND SHIRE WATERCOURSE  
ASSESSMENT & REHABILITATION  
PRIORITISATION**

**VOLUME 2  
CHAPTER 3**

**HACKING RIVER  
CATCHMENT PROFILE**

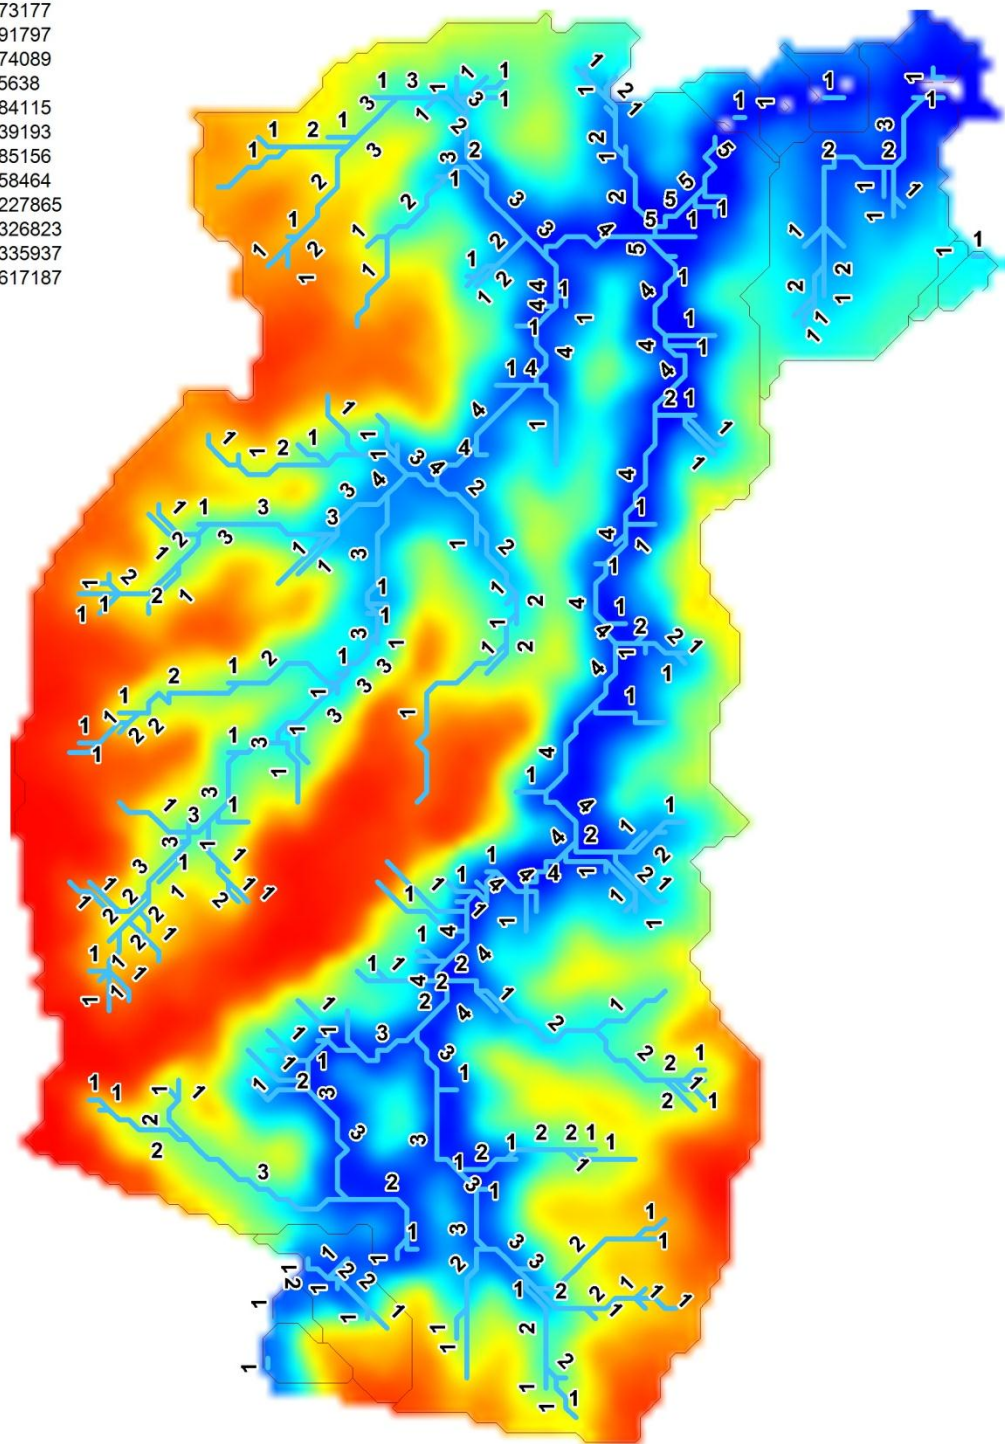
### CATCHMENT ELEVATION MODEL: STREAM ORDERS AND CATCHMENT BOUNDARIES

ELEVATION (metres)
