**Proposed Mixed-Use Development  
138 Cronulla Street, Cronulla NSW**

Geotechnical Investigation

Our ref: 5533-G1  
6 May 2019

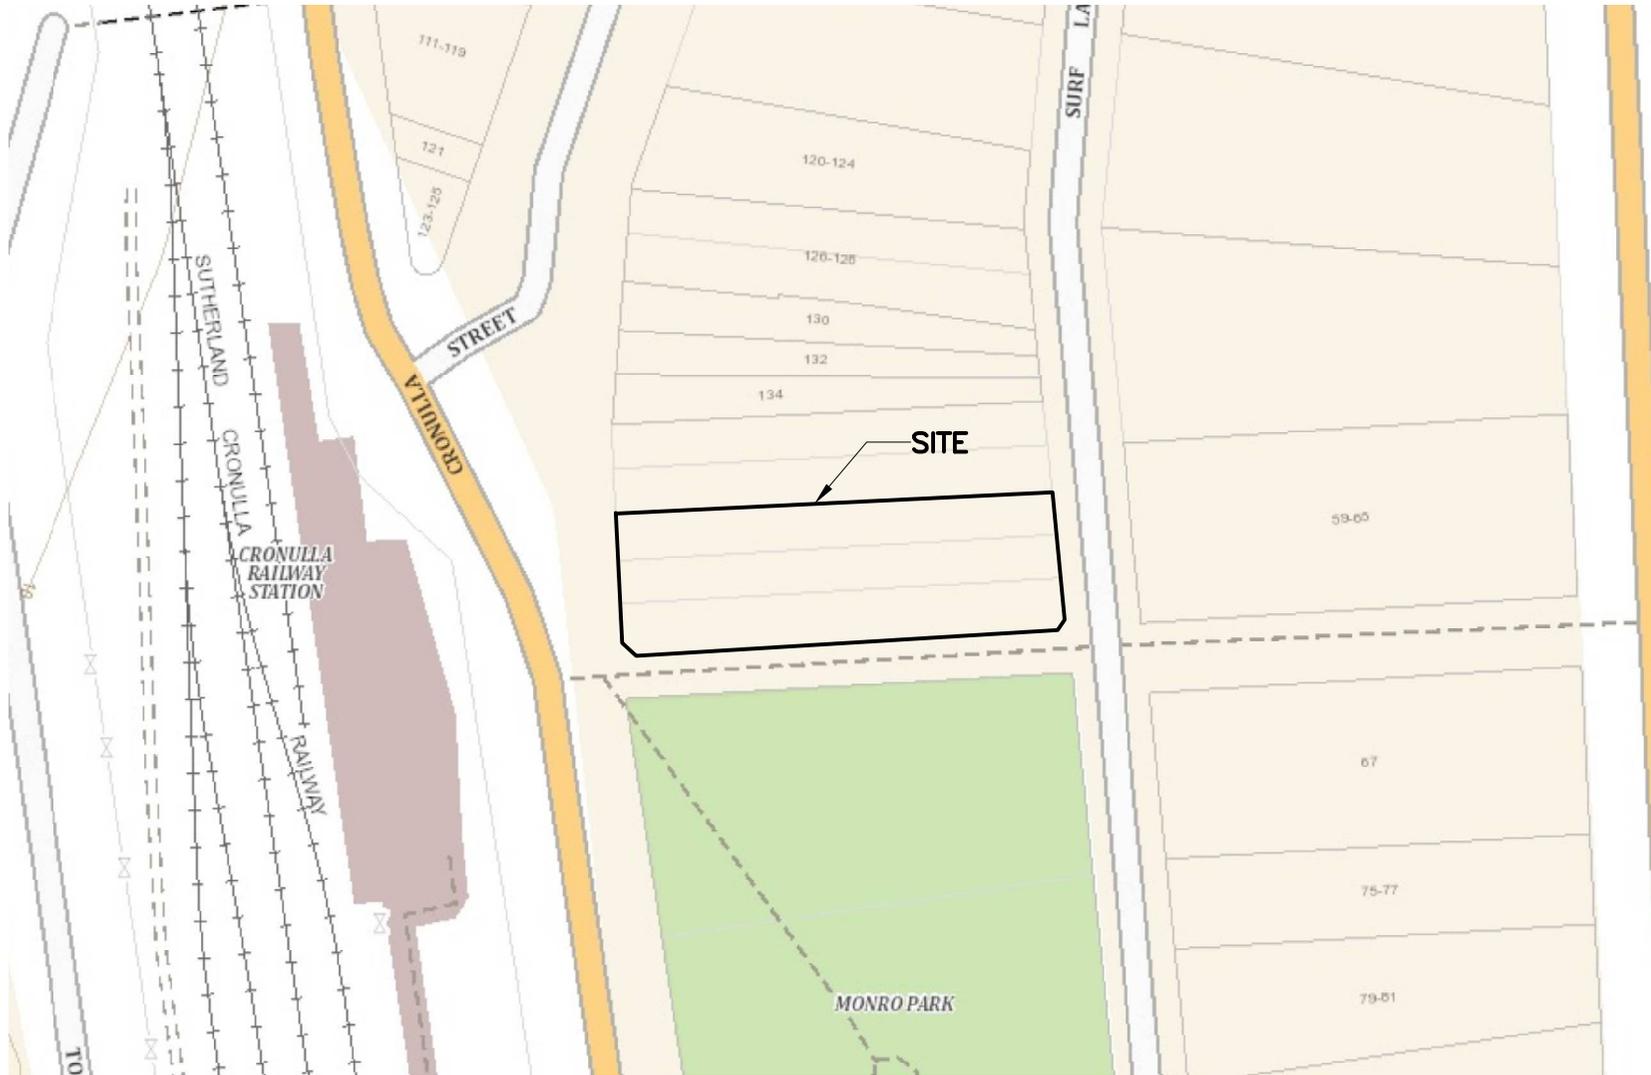
SITE LOCALITY

APPROXIMATE ONLY –  
SUBJECT TO DETAIL SURVEY.

SOURCE: SIX MAPS

The site is located on the eastern side of Cronulla Street, as shown in Figure 1. The site is bounded to the west by Cronulla Street, to the east by Surf Lane, to the north by commercial building and to the south by Beach Park Avenue.

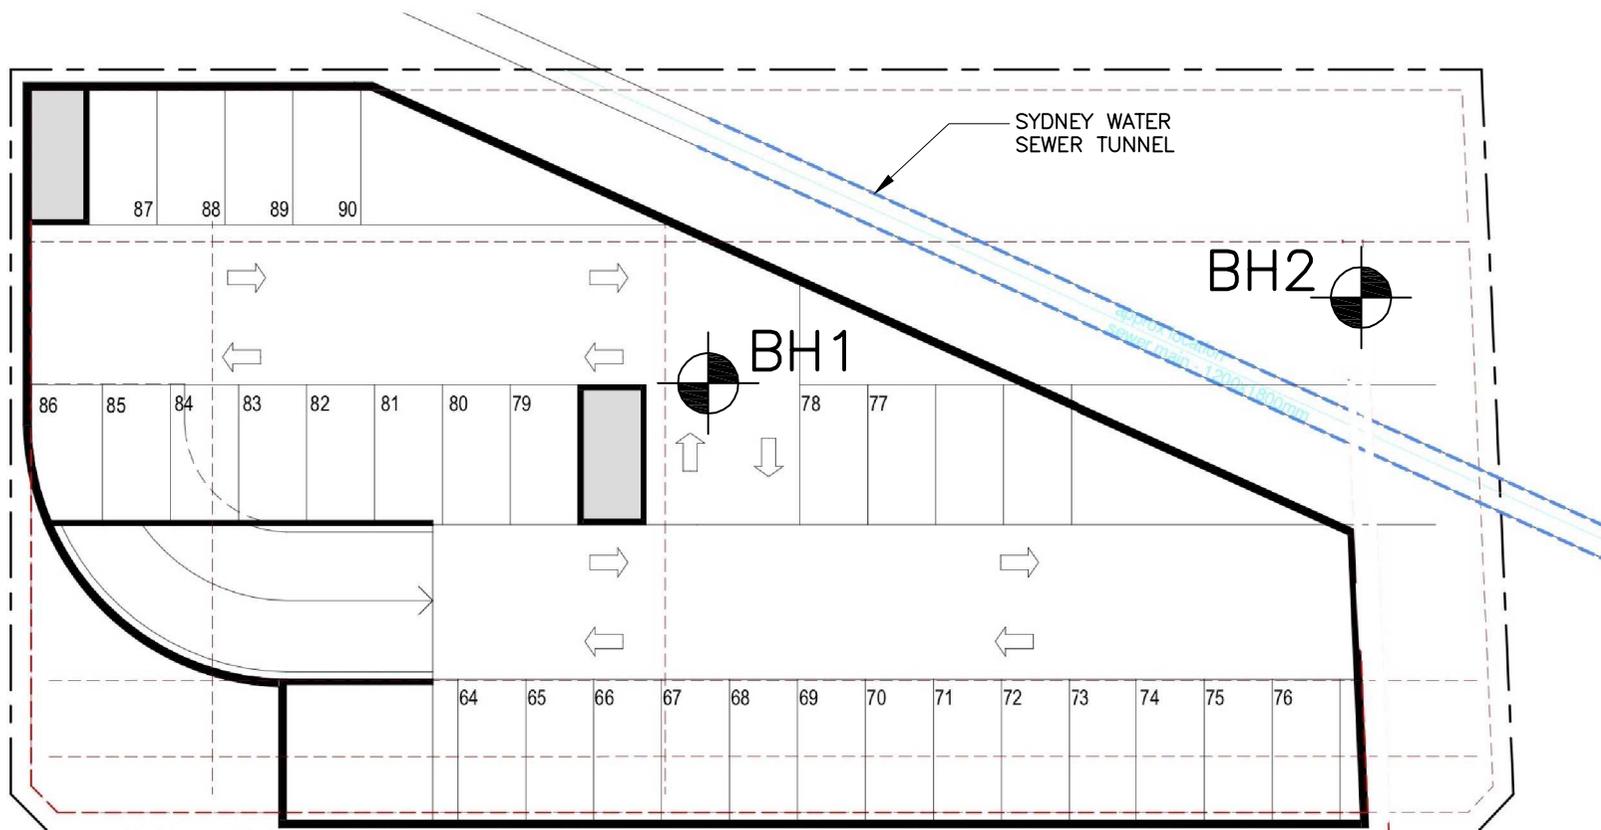
**KEY**

The test locations are shown in the attached Figure 2 and were set out by our Geotechnical Engineer by measurements relative to existing site features.
