SUTHERLAND SHIRE COUNCIL

JUNE 2005

Webb, McKeown & Associates Pty Ltd Level 2, 160 Clarence Street, SYDNEY 2000 Telephone: (02) 9299 2855 Facsimile: (02) 9262 6208 23078:OysterCreekFloodStudy.wpd Prepared by: _____

OYSTER CREEK FLOOD STUDY

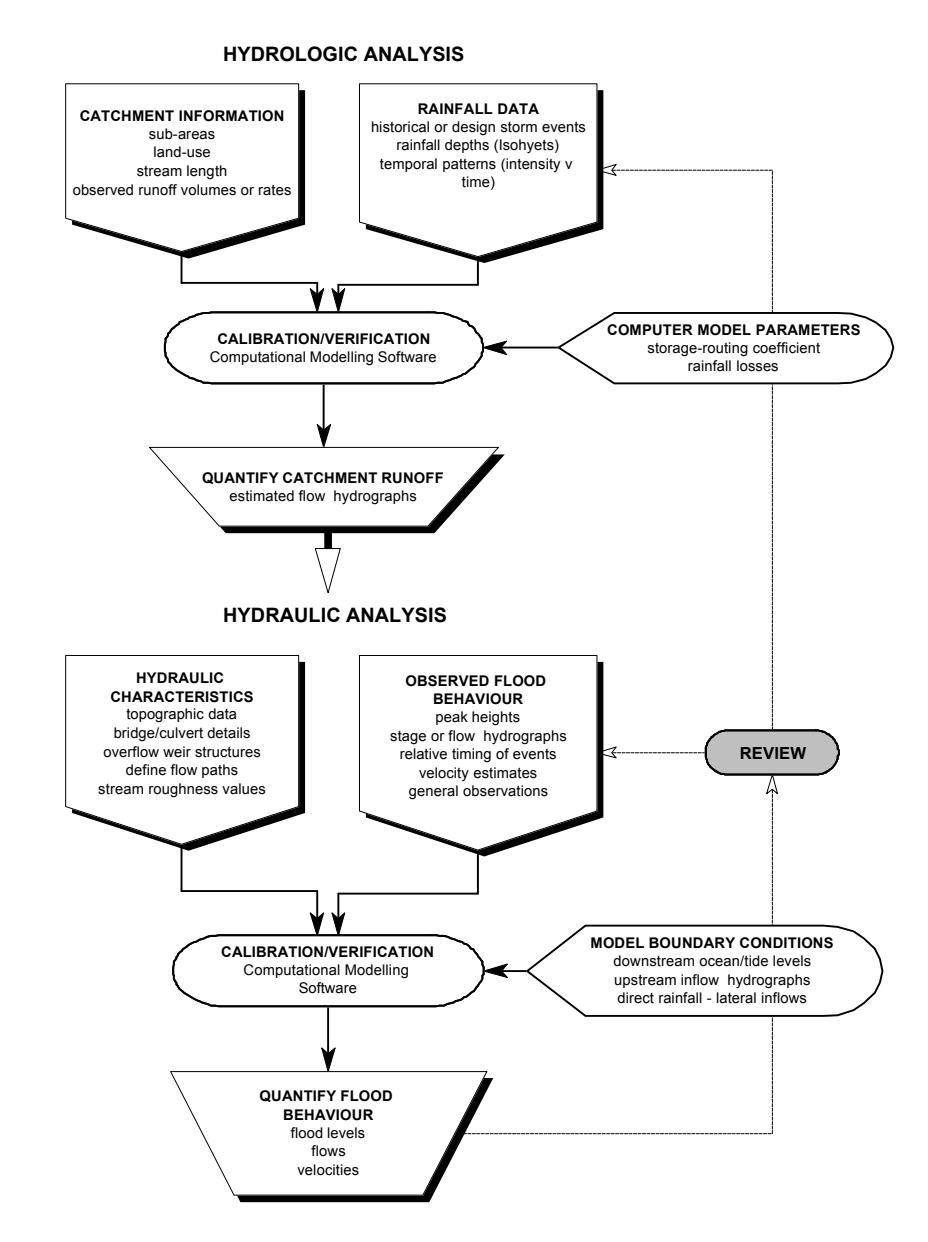
Diagram 1: Flood Study Process

A diagrammatic representation of the Flood Study process is shown in Diagram 1. A hydrologic model (WBNM) was established for the entire catchment (Figure 6) and used to convert rainfall data into streamflow for input to a hydraulic (MIKE-11) model of Oyster Creek (Figure 7). To ensure confidence in the results, both models require calibration and verification against observed historical events. With the limited amount of rainfall and flood data available and given the lack of any stream gaugings, the model calibration process focussed on ensuring the design flood levels are compatible with the expected frequency of the known historical events. The calibrated MIKE-11 model was then used to quantify the design flood behaviour for a range of design storm events up to and including the Probable Maximum Flood (PMF).
