# North West Arm

## Coastal Zone Management Plan

Prepared for  
Sutherland Shire Council

9 September 2015

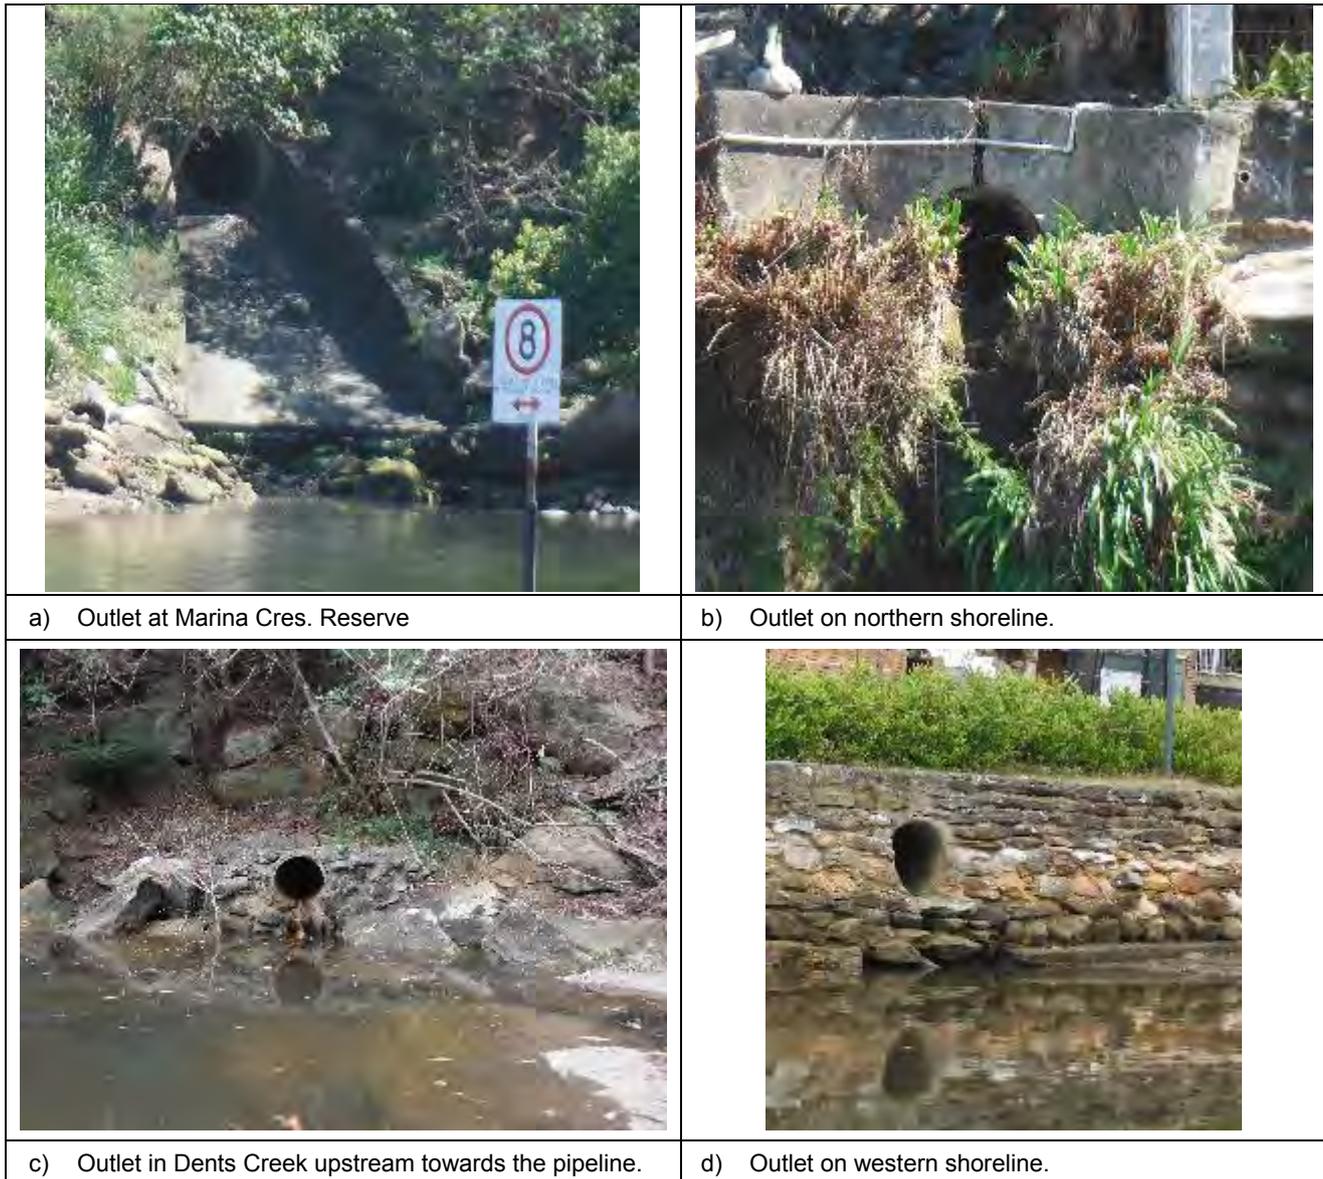
**Figure 6-5: Council Stormwater Outlets**

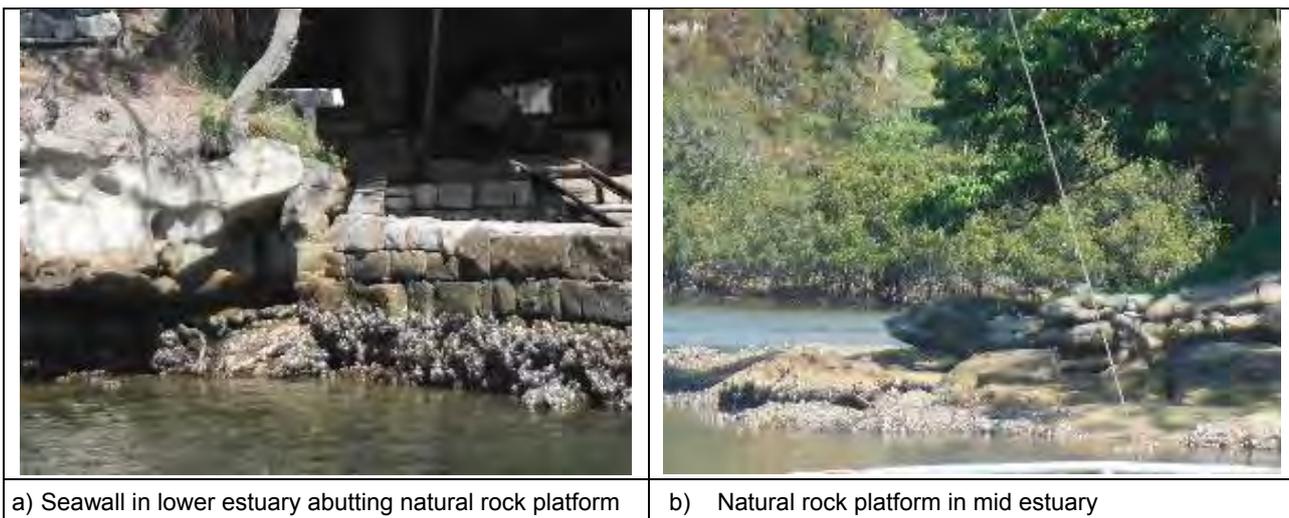
**Figure 7-1: Rocky shores and seawalls in the North West Arm**

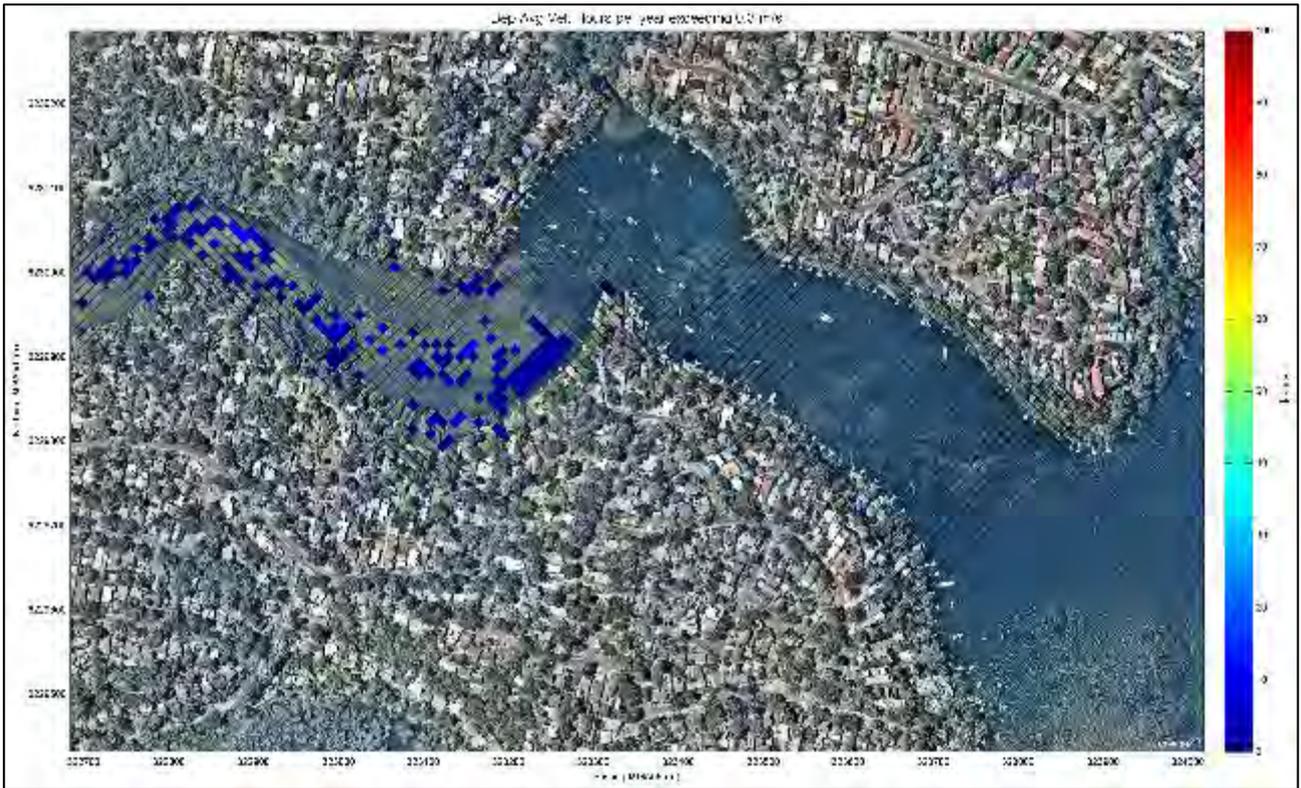
**Figure B-4: Hours per Year Above Sediment Transport Threshold (0.4 m Sea Level Rise)**

This shows that tidal currents have little impact upon the morphodynamics of the study area. Further, as mean sea level increases under climate change conditions, the influence of tidal currents on bed load transport decreases, predominantly due to increased water depths (see **Figures B-4 and B-5** in **Appendix B**).

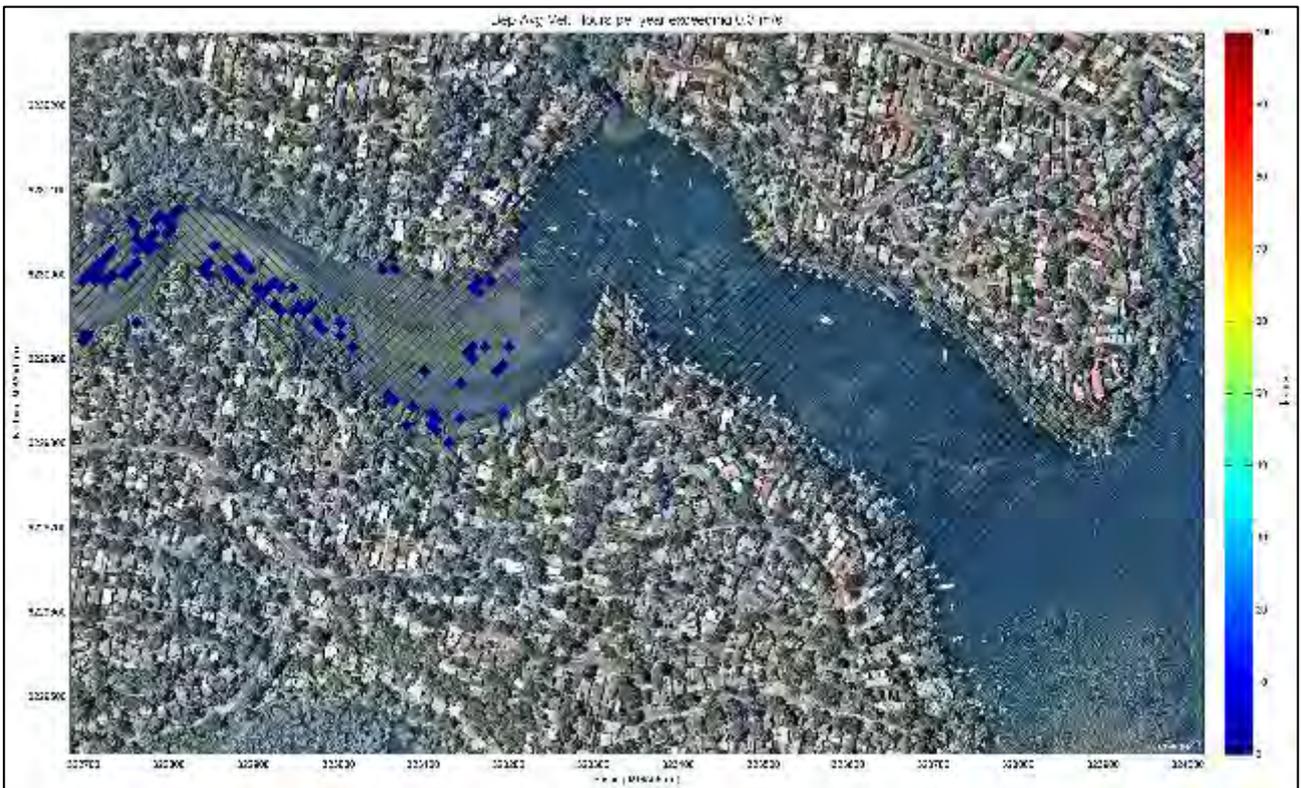
**Figure B-5: Hours per Year Above Sediment Transport Threshold (0.9 m Sea Level Rise)**

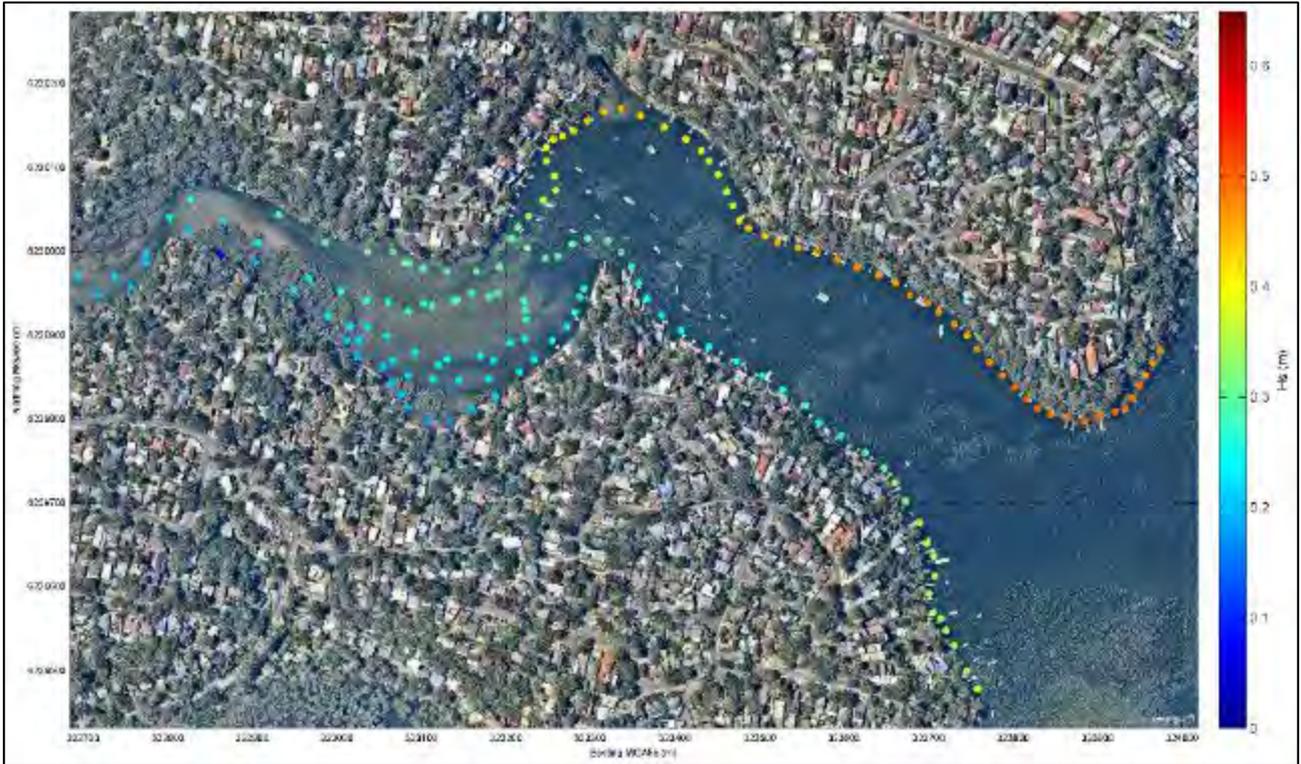
Figure B-11: 20 years ARI Significant Wave Height (m) (0.4 m Sea Level Rise)

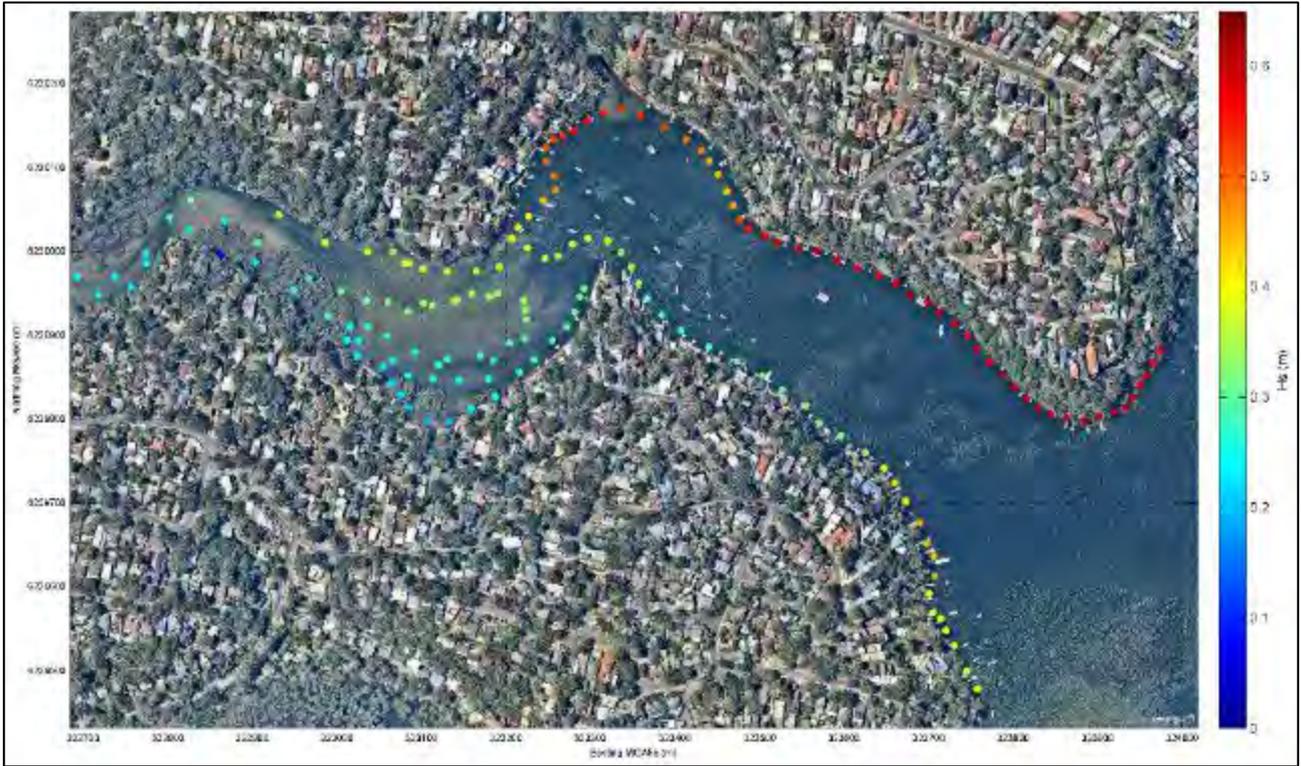
Figure B-17: 200 years ARI Significant Wave Height (m) (0.4 m Sea Level Rise)

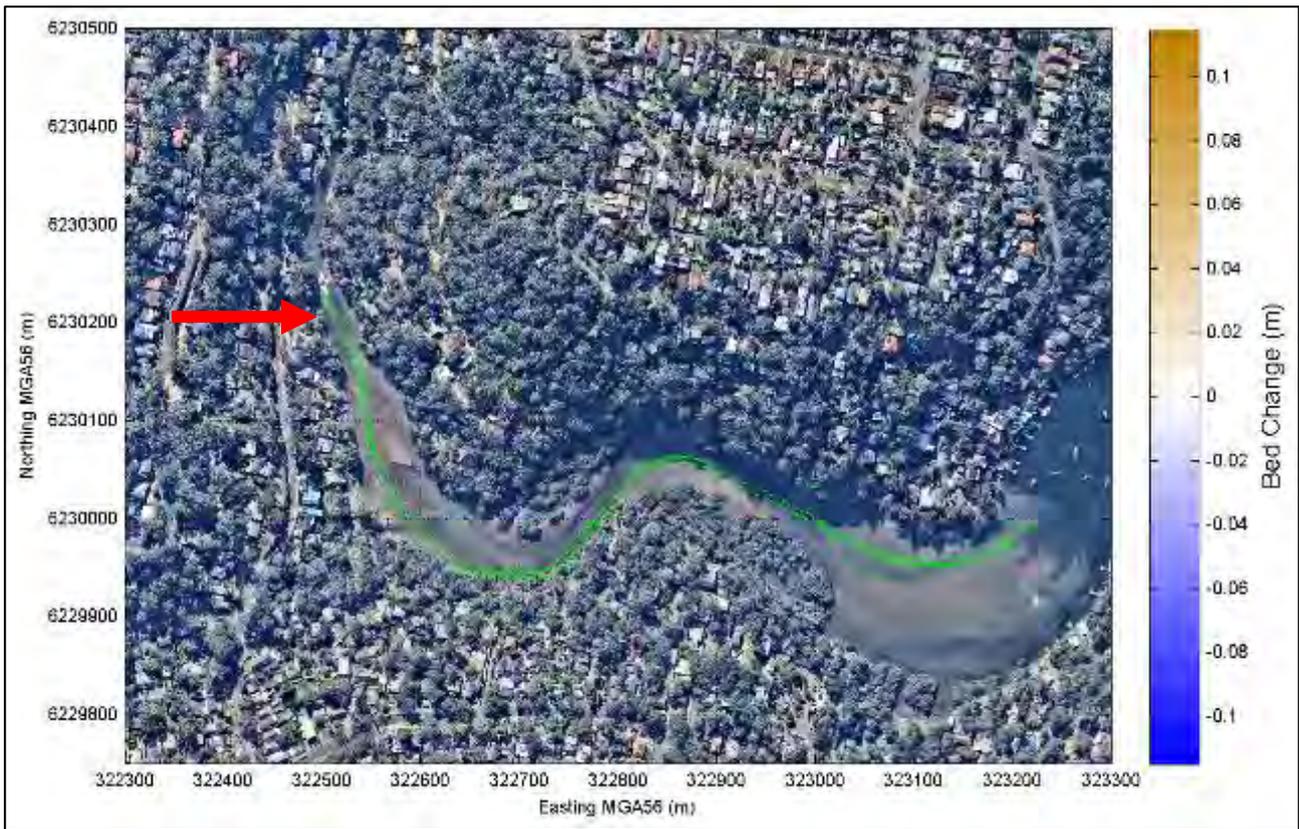
**Figure C-2: Tidal Redistribution of Sediments Over One Year – Option 1 (as indicated by the red arrow)**

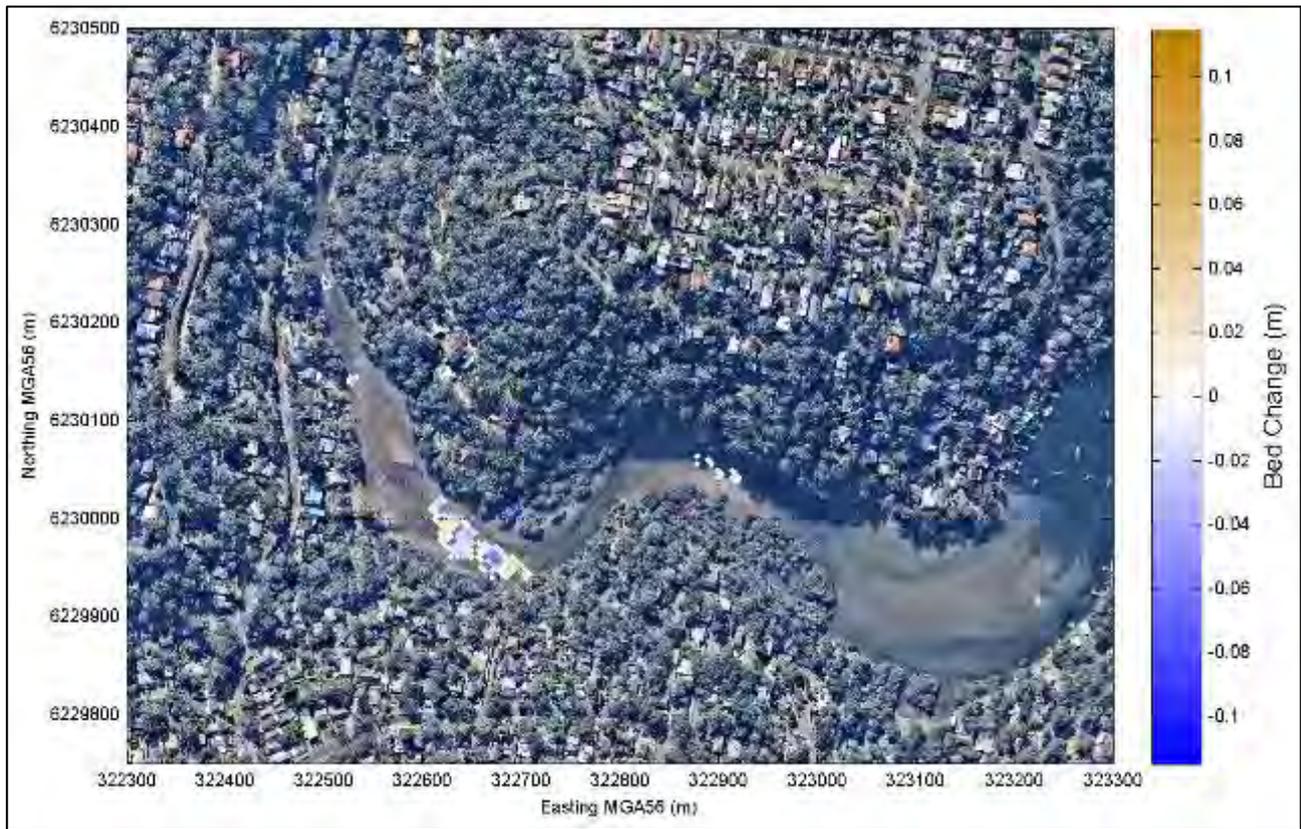
**Figure C-4: Tidal Redistribution of Sediments Over One Year – Existing Bed Condition (i.e. do nothing)**

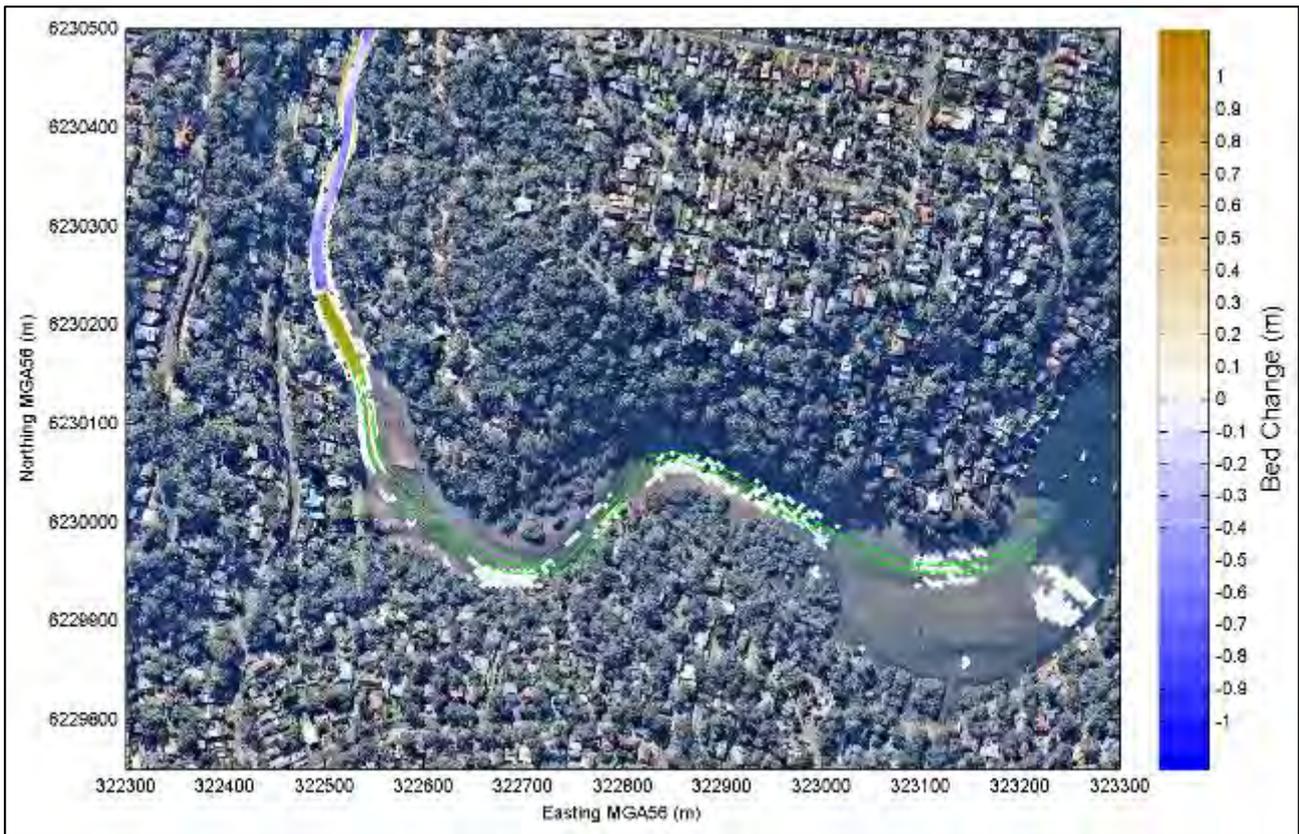
**Figure C-5: 1-Year ARI Catchment Flood Erosion and Sedimentation – Option 1 – High Sediment Load**

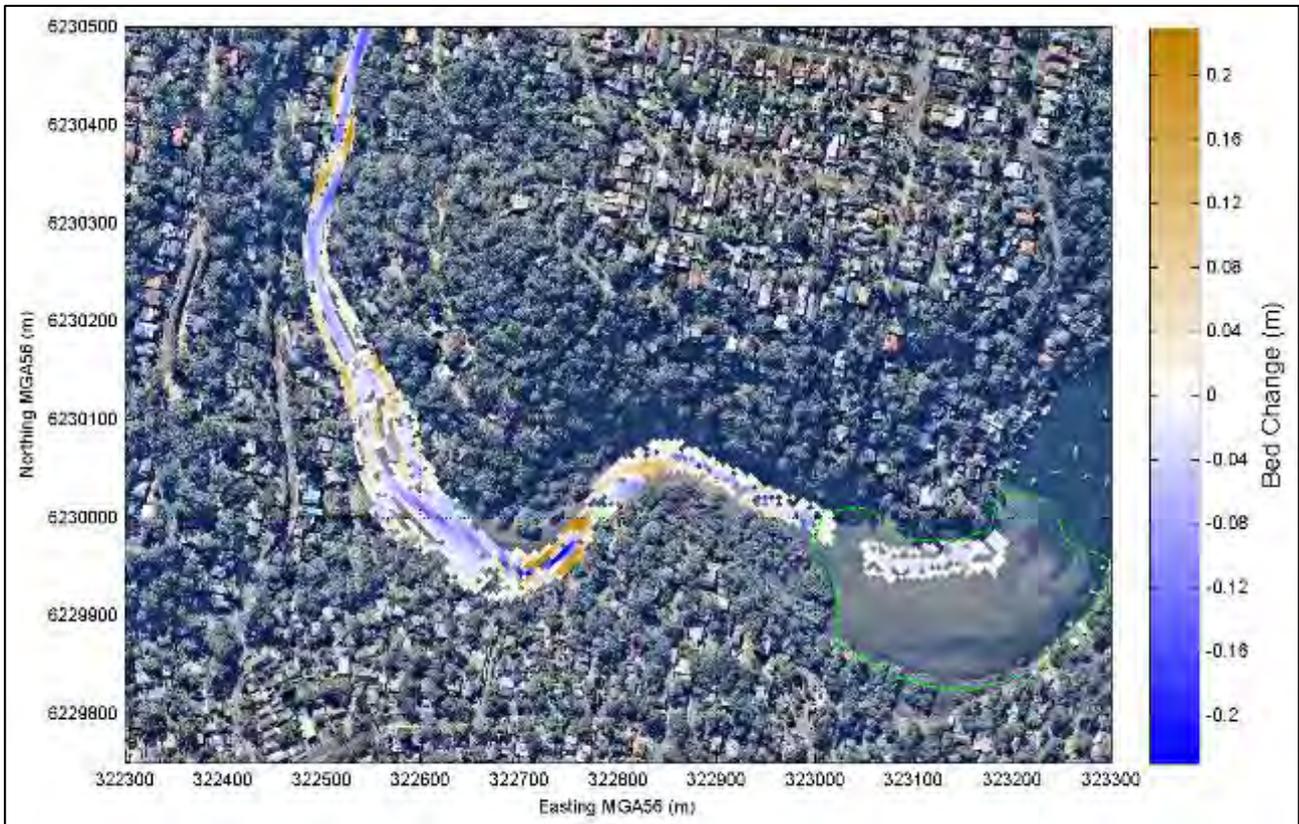
**Figure C-6: 1-Year ARI Catchment Flood Erosion and Sedimentation – Option 2 – High Sediment Load**

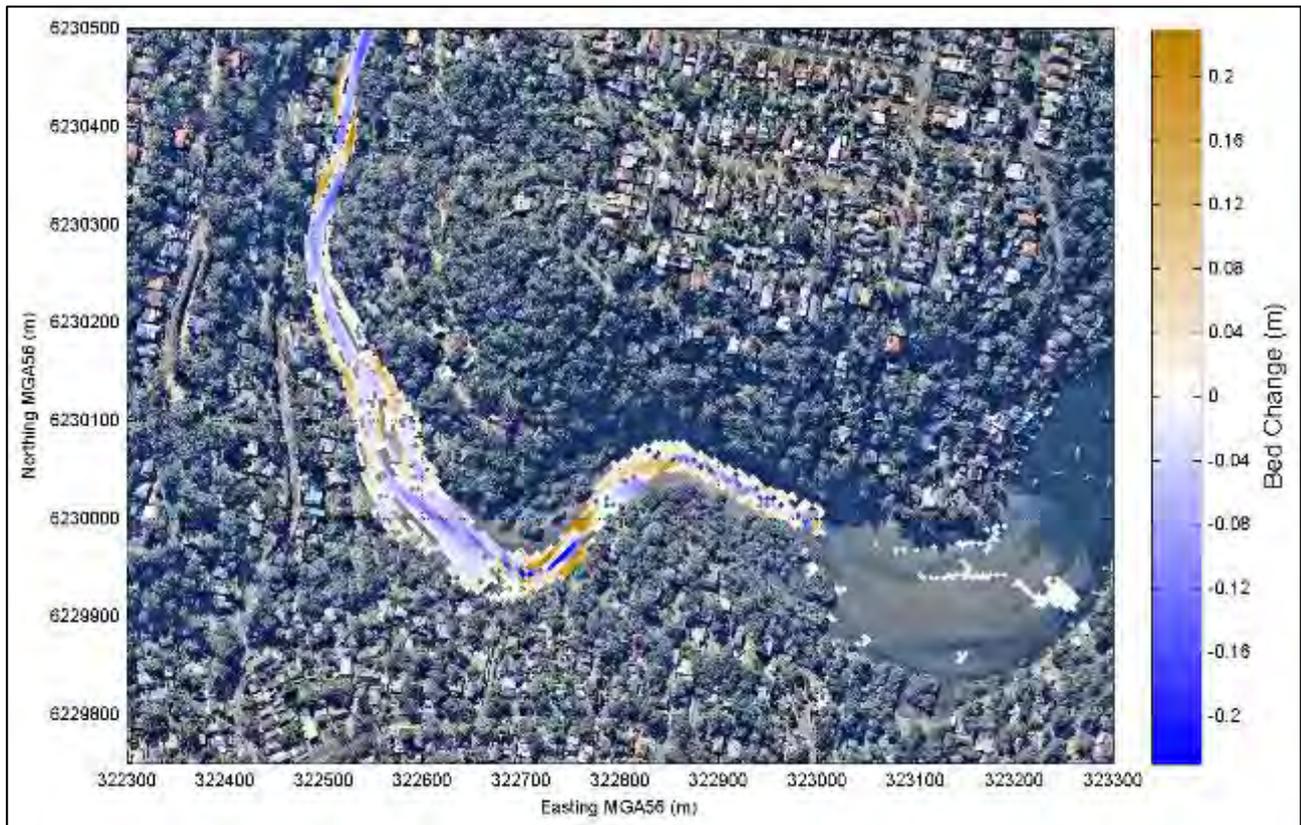
**Figure C-7: 1-Year ARI Catchment Flood Erosion and Sedimentation – Existing Bed Condition (do nothing option) - High Sediment Load**
